Ahmedabad Urban Road Accident Study 2016

Comprehensive analysis of 156 accidents examined between January to December 2016

JP RESEARCH INDIA PVT LTD
No.703, Sakar-3, Ashram Road,
Near Income Tax Circle,
Navrangpura, Ahmedabad - 380014
Gujarat, India.
Phone: +91-79-4007 7714/15/16

COMMISSIONER OF TRANSPORT, GOVT. OF GUJARAT
2nd Floor, Block No. 6, Dr. Jivraj Mehta Bhavan,
Gandhinagar – 382010, Gujarat

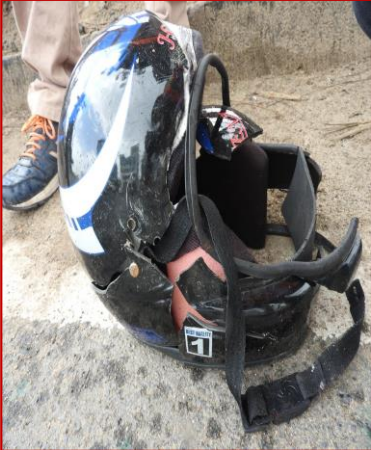
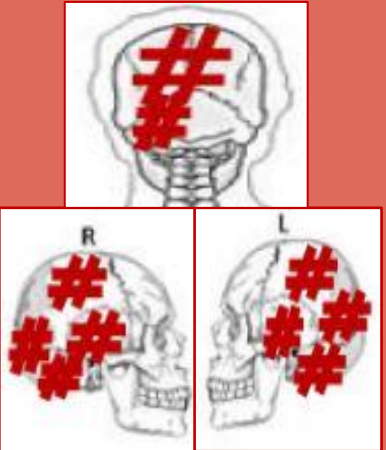
Occupant role	Rider	Pillion rider
Injury Severity	Minor	Fatal
Occupant impact/ contact area	Front fascia of the bus and the ground	Front fascia of the bus and the ground
Contributing factors - Lead to the Injury	Knock down to ground	Knock down to ground Helmet not used
Impact forces were taken by

Result	Destroyed helmet	Fractured skull

Although, the injury causation conditions were same for the riders of the motorcycle, the sole factor that made a substantial difference in the injury outcome was the usage of helmet by the rider of the motorcycle. The helmet absorbed all the impact forces directed to the head of the motorcycle rider and shielded it completely. The pillion rider whose head was unprotected died due to head injuries.

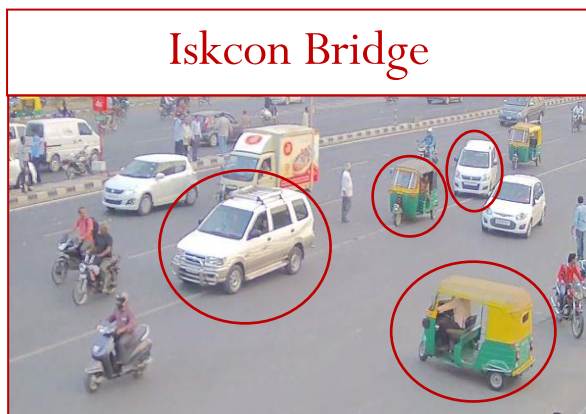
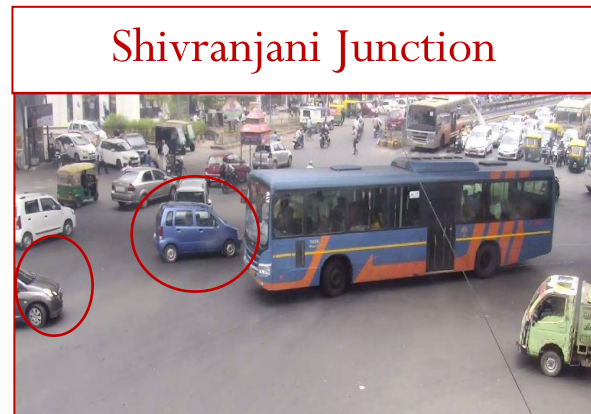
Improper lane change/ Lane usage – 13%

Improper lane change and improper lane usage is a driver behavioural error that topped the list for being the most common reason behind accident occurrence. Improper lane change is due to a driver/ rider either weaving diagonally across lanes (rather than moving through one after another in an orderly progression) or failing to check mirrors or indicate intention to other drivers before changing lanes, catching other drivers by surprise. Many motorcyclist and motorists have been observed changing lanes without giving proper indication or trying to squeeze themselves between the tiny gaps present in traffic. Improper lane usage includes travelling on shoulder of roadways, travelling on wrong lanes for conditions (Taking right turn from center or left lane) and travelling partially on more than one lanes. Turning suddenly or without indication is a similar scenario where the driver performs a precipitous turning maneuver.

Use of indicators to communicate to other drivers about the intention to turn or change lanes is important and must be mandated for safe driving. Proper lane discipline can be enforced through educating drivers to use the left (slow) lanes in all possible conditions unless they need to overtake. The right most lane (fast lane) should be used only as an overtaking lane.

Road marker cats eye/ road stud placed on road marking of a highway are effective solutions to warn driver of an improper lane change / lane usage. This alerts the driver acoustically (tyre noise) and physically (vibrations) once the vehicle is driven over it. This makes the driver travel in one particular lane and reduces frequent lane changing practice. This also serves as lane and road delineators during night time.

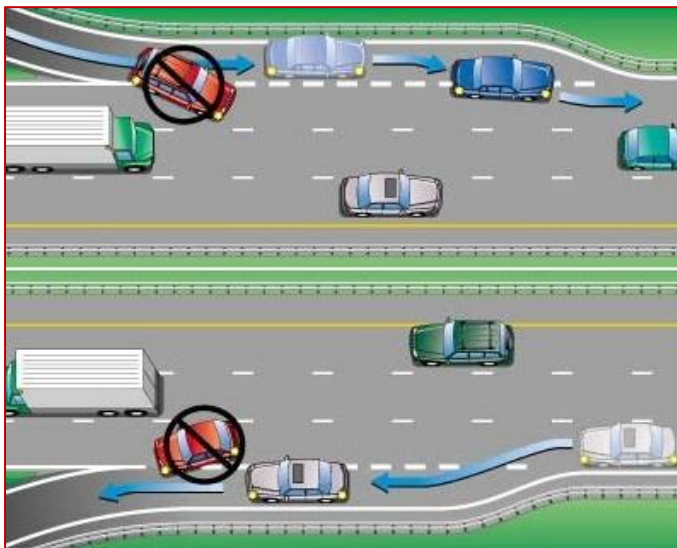
Infrastructure solution: Speed change lanes or auxiliary lanes or turning lanes

These lanes are an important element of infrastructural improvements which has to be planned in the design phase, so as to allow steady change in travel speed and to let turning maneuvers happen outside of the main (through) traffic flow.

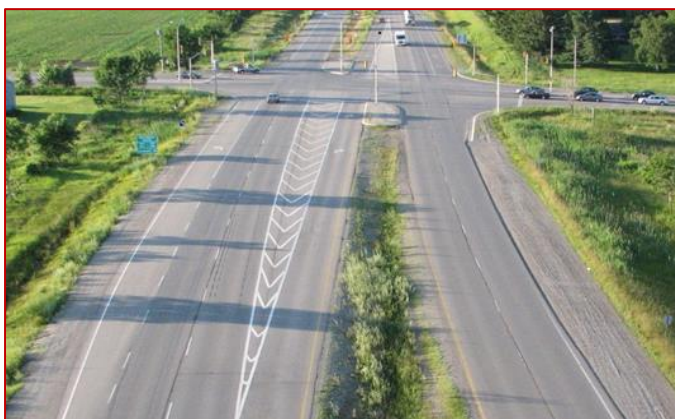
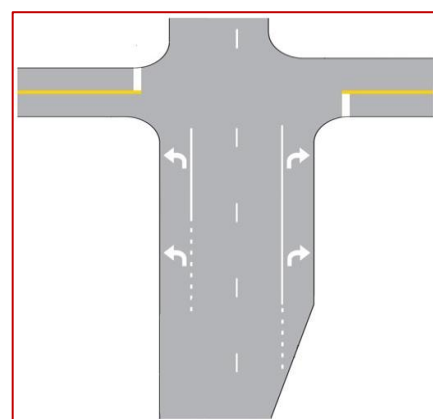
Acceleration/ deceleration lane (auxiliary lane) includes tapered areas, for the purpose of enabling a vehicle entering/ exiting a roadway to increase/decrease its speed to a rate at which it can more safely merge with through (main) traffic.

A sudden lane change, so as to perform a turn maneuver is highly undesirable and is likely to cause a rear end collision and this situation can be avoided by creating right/ left turn lanes. These are similar to auxiliary lane, includes tapered areas or diverging lane, which demands prior lane change maneuvers so as to gain access to perform a turn maneuver. This lane also accommodates the stop-go traffic conditions (during peak hours) without disturbing the through (straight) traffic flow.

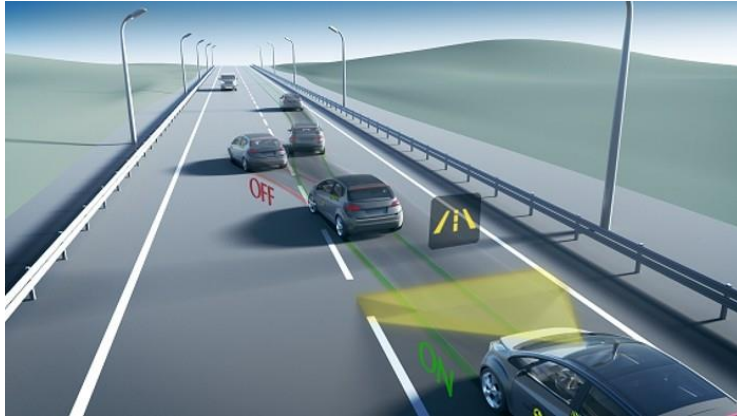
Vehicle Engineering: Lane Departure Warning Systems

Many times, drivers forget or do not care to signal other road users before negotiating a turn maneuver. The lane departure warning system, has a camera or sensors that tracks the road markings and the vehicle's movement with respect to the markings. In case of departure from the travel lane without the use of turn indicators, the system sends in visual,

acoustical and physical warning (differs from individual systems). If the driver fails to react, the system automatically activates the brakes on one side of the vehicle and help guide the vehicle back into the travel lane, thus encouraging the practice of using turn indicators to signal a lane change maneuver.

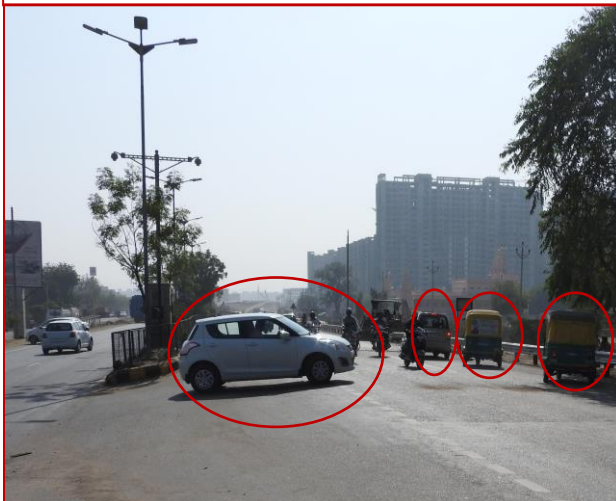
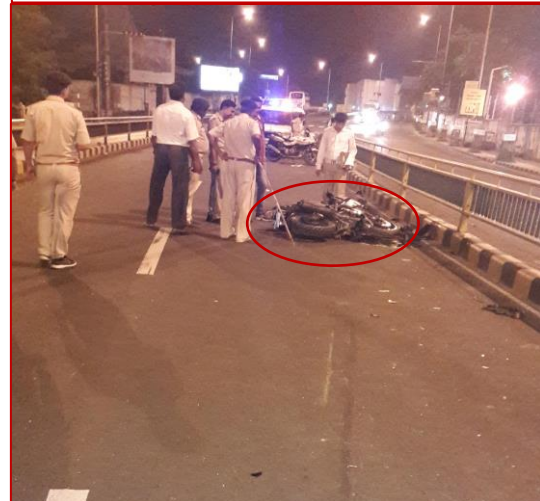
Illegal road usage (includes travelling in the wrong direction) - 12%
(9 M2Ws, 4 Cars, 2 Buses, 2 M3Ws, 1 Truck, 1 Bicycle)

Illegal road usage is a driver/ rider behaviour related (human) error which lead to the occurrence of an accident in at least 12% of the total 262 vehicles considered in the study. This is crucial factor because in most occasions this human error is seen to be performed deliberately for meagre gains.

Illegal road usage includes wrong-way driving which is the act of driving a motor vehicle against the direction of traffic. This may be due to driver inattention or impairment, or because of insufficient or confusing road markings or signage. Also in many occasions people intentionally drive in the wrong direction because they missed an exit or to access a roadway whose access point (to access other side of a divided roadway) is a tad far, so they prefer to drive wrong way jeopardizing safety of all other road users and theirs in order to save fuel and time. Habitual wrong way driving can commonly be observed in places like Khodiyarnagar junction, Odhav fire station junction, Shri Dongre Maharaj Marg and many more places in Ahmedabad city, such drivers never even see this as a violation.

Not always the vehicle users are at fault, in some occasions improper positioning of gap in medians, work zones, poor intersection design, poor access road to service and connecting roads confuses or displeases a road user and leads to wrong way driving. Illegal road usage also includes driving on limited access roadways or restricted roadways like BRTS corridor where access is restricted only to certain buses. Travelling in such restricted highways poses a greater risk for other road users as the roadway is designed specifically for travelling of particular type vehicle and, all road features and equipment incorporated may not suit other vehicle user and in many occasions may cause several safety issues. For example positioning of signage and other road safety equipment in this roadway might be positioned considering the ride height of the vehicle, average speed of travel etc.

Violations such as travelling in wrong direction is likely to endanger other road users and hence must be treated as a serious crime. Road users liable to such crime must be penalised with suspension of license and hefty fine amounts.

Unintentional wrong way driving can be prevented by adding signboards with LED lights which will naturally grab the attention of the driver and also reduces navigational issues. Repetitive and effective positioning of signboards may also help reduce unintentional violations.

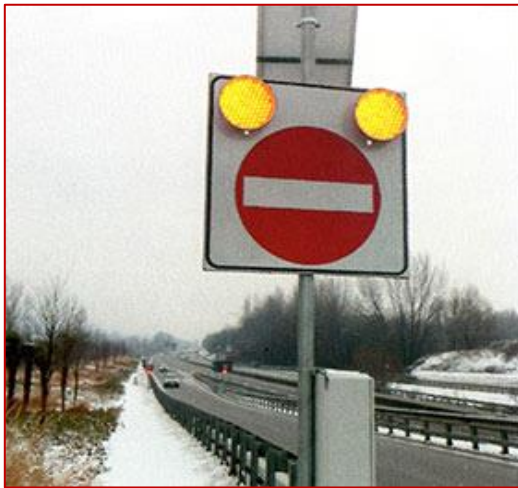
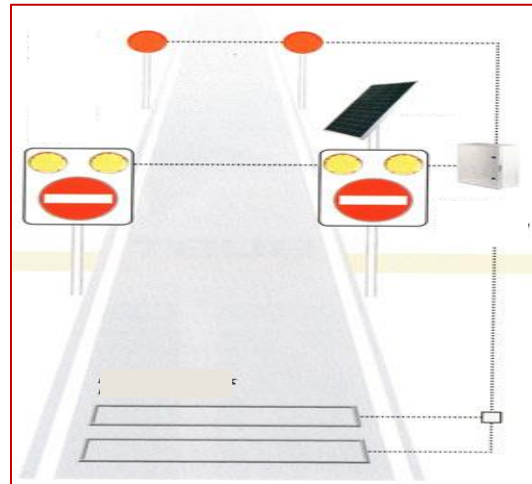
Infrastructure solution: Automatic wrong way detection device

This system might be helpful in preventing intentional wrong way driving. This solar powered device tracks the movement of vehicle in the wrong direction using radar technology or induction technology, provides advance warning by activating the blinkers, thus alerting the vehicles travelling in the correct directing about the impending danger. This system can also be integrated with cameras which shall help penalise the violators, thus keeping a check on wrong way driving.

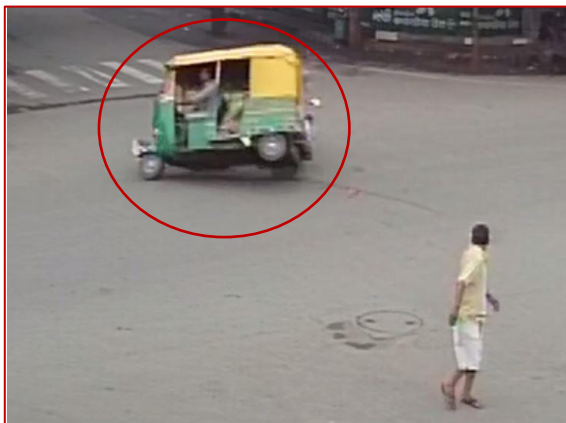
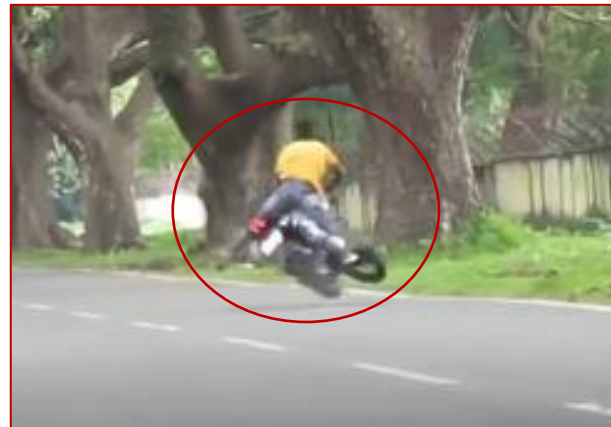
Sudden steering / braking / both - 10%
(12 M2Ws, 2 Cars, 2 M3Ws)

Sudden steering/ braking/ both in most cases is a sudden avoidance maneuver that precipitated the accident, like a motorized two wheeler rider braking suddenly to avoid colliding against a crossing animal, where he/she might have successfully avoided the impact with dog but slipped and fell down as a result of braking. This is very common contributing factor leading to an accident in city conditions, and can be due to traffic and non-traffic condition. As far as this factor is concern, in most occasion the road users who actually created a critical situation are not the ones who meet with an accident.

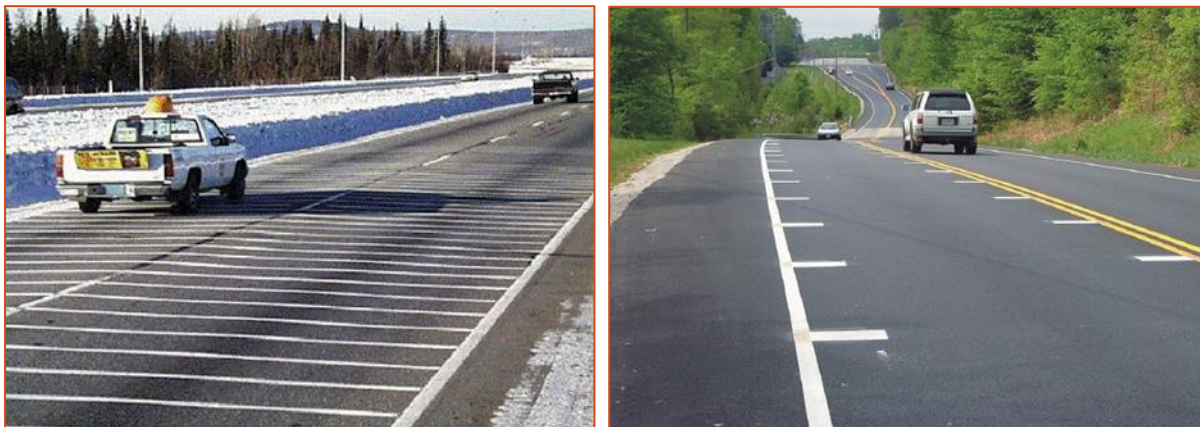
Infrastructure solution: Perceptual pavement marking

Perceptual cues are one potential method of influencing motorists to slow down, and ultimately save lives. Perceptual pavement markings are low cost countermeasures for speeding and decreased attention. Perceptual pavement markings give the driver the illusion of traveling faster than his or her actual speed in order to decrease the driver's comfort at excessive speeds. At locations where drivers are expected to reduce their speed, such as the beginning of a school zone, approach to an intersection, or prior to a sharp horizontal curve, a converging pattern of pavement markings can be used to give the perception to the drivers that they are increasing their speed if they fail to slow down at a sufficient rate. Pavement markings can also be used for other perceptual applications, such as to give the illusion of lane narrowing. This method is intended to reduce a driver's comfort at an excessive speed while proceeding through the markings, as a way to encourage deceleration. This type of treatment has potential applications along the entire length of a corridor. There are various types of perceptual pavement markings like transverse line markings, peripheral transverse line markings, converging chevron markings, Dragon's teeth, etc., and all of them serve the same purpose of speed reduction and to attract driver's attention.

Though it requires periodic maintenance, it is still an effective and economic solution to mitigate speeding related accidents.

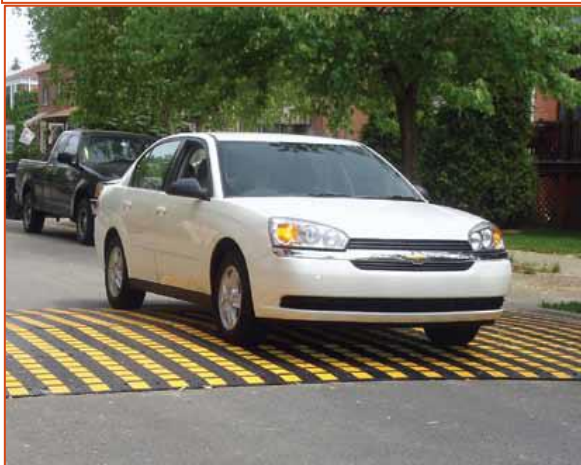
Speed humps are traffic calming devices which are similar to speed breakers/ speed bumps, but are used where a less drastic vehicle slowing is desired. This can be installed on main roads just before an approach to an intersection so as to bring down the speeds to a moderate level and, will also reduce the reaction time while encountering critical situations as this feature grabs the attention of the road user. If this system is planned (planning also includes forecasting of vehicle population growth) and installed properly, those roads will see a better average travel speed than the roads installed with repetitive speed bumps, thereby saving driving time and reducing driving related frustration.

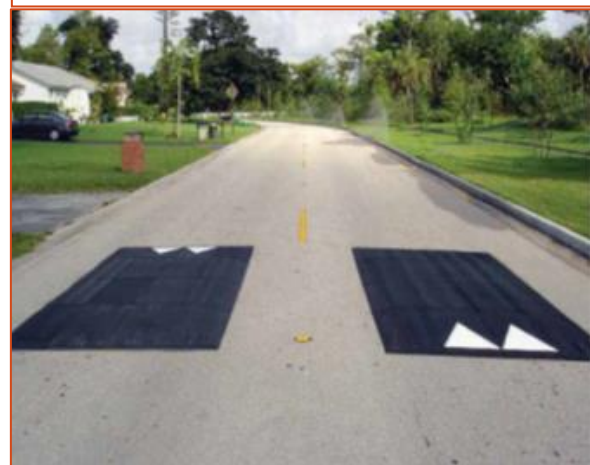
Speed cushions are similar structures which are used specifically to reduce the travel speed of certain lanes. This when installed on the fast lanes (right lanes) or deceleration lane before an intersection, compels the road user to reduce their travel speed before a turning maneuver or before passing through an intersection, thereby reducing the probability of occurrence of an accident. Positioning of these structures must be planned properly so as to avoid vision obstruction problems due to slowing vehicles.

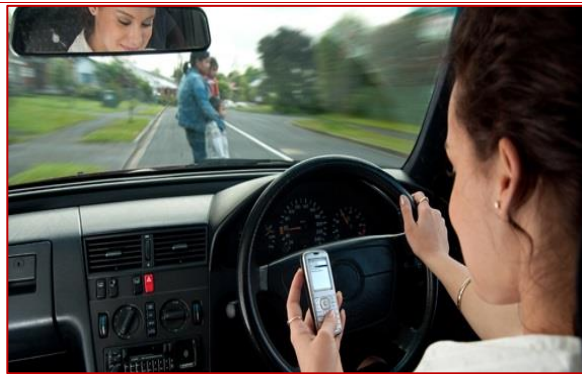
Mobile phone

Driver inattention or poorly allocated attention is basically a human error where the driver gets distracted in the course of driving a vehicle. Distracted driving occurs when some kind of triggering event external to the driver, results in the driver shifting attention away from the driving task. Distraction can be from inside or outside the vehicle.

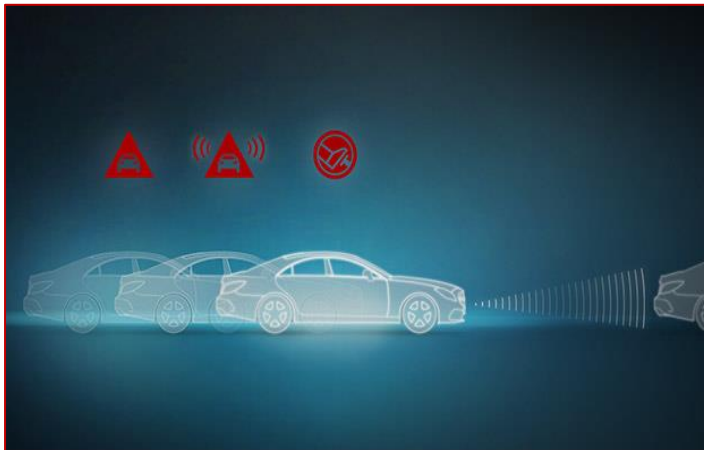
Vehicle Engineering: Forward collision warning with adaptive braking

This system uses cameras, radars or both to detect the risk of an impending collision. Typically, the driver is first alerted visually and acoustically. This is followed by pre loading of brakes to provide maximum braking once the brake pedal is pressed. If the driver fails to react and if the system detects that the crash is imminent, the system initiates automatic braking system and brakes are applied automatically.

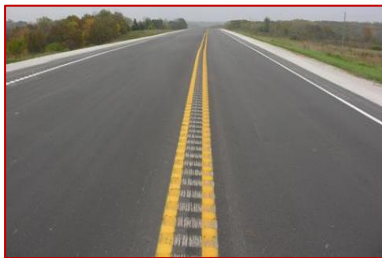
Infrastructure solution: Continuous Rumble Strips

Continuous rumble strips are designed to alert inattentive drivers to potential danger by causing a tactile vibration and audible rumbling, transmitted through the wheels into the vehicle's frame. A continuous rumble strip is usually applied along an edge or centreline to alert drivers when they drift from their lane.

Rumble strips are effective (and cost-effective) for reducing accidents due to inattention or sleepiness, and they are also effective for keeping drivers in their lanes in low visibility conditions such as fog or dense rain. Shoulder rumble strips are most effective when they are a part of a wide, stable shoulder which can be used to regain control of the vehicle. That is, the driver should have enough space to maneuver the vehicle back onto the road in case of a sudden loss of control. Such strips may also prevent drivers from using the shoulder lane as an overtaking lane.

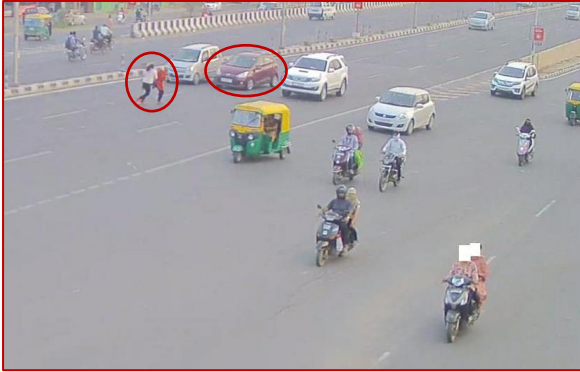
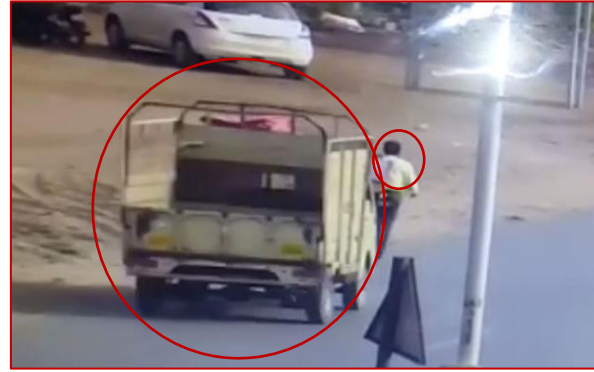
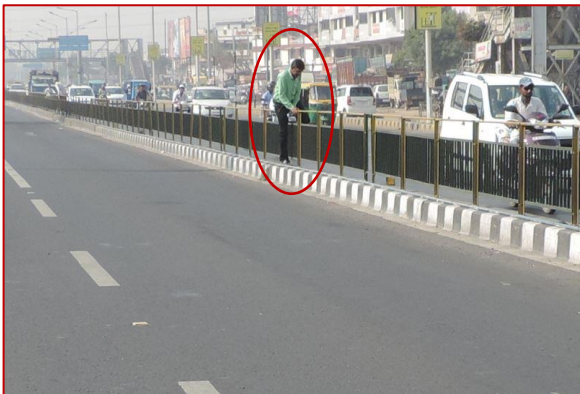
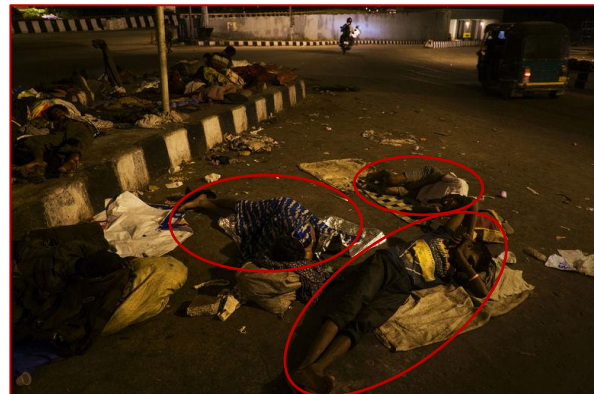
Pedestrian dangerous behaviour on roadway - 12%

Pedestrian dangerous behaviour is the leading pedestrian related human factor which contributed to the occurrence of accidents to 49% of pedestrians considered in this study (a total of 39 pedestrians were a part of this study).

Pedestrian dangerous behaviour is a scenario where the pedestrian's unsafe action led to an accident. This includes situations where pedestrians attempt to cross the road hurriedly or jump a fence/ median, putting their lives and other road user's lives in peril.

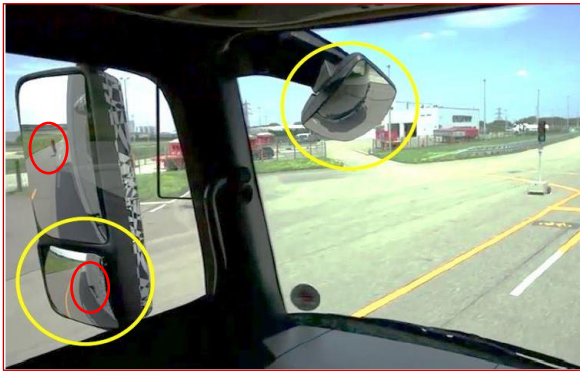
Vehicle Engineering: Additional rear view mirrors

All heavy vehicles must be incorporated with multiple rear view mirrors which covers all or majority of the vehicle's surrounding areas. Areas surrounding the rear of the vehicle can be seen through cameras or reverse assistance sensors can come in handy to solve this problem. This is also much convenient for the drivers and brings in more confidence in reversing the vehicle.

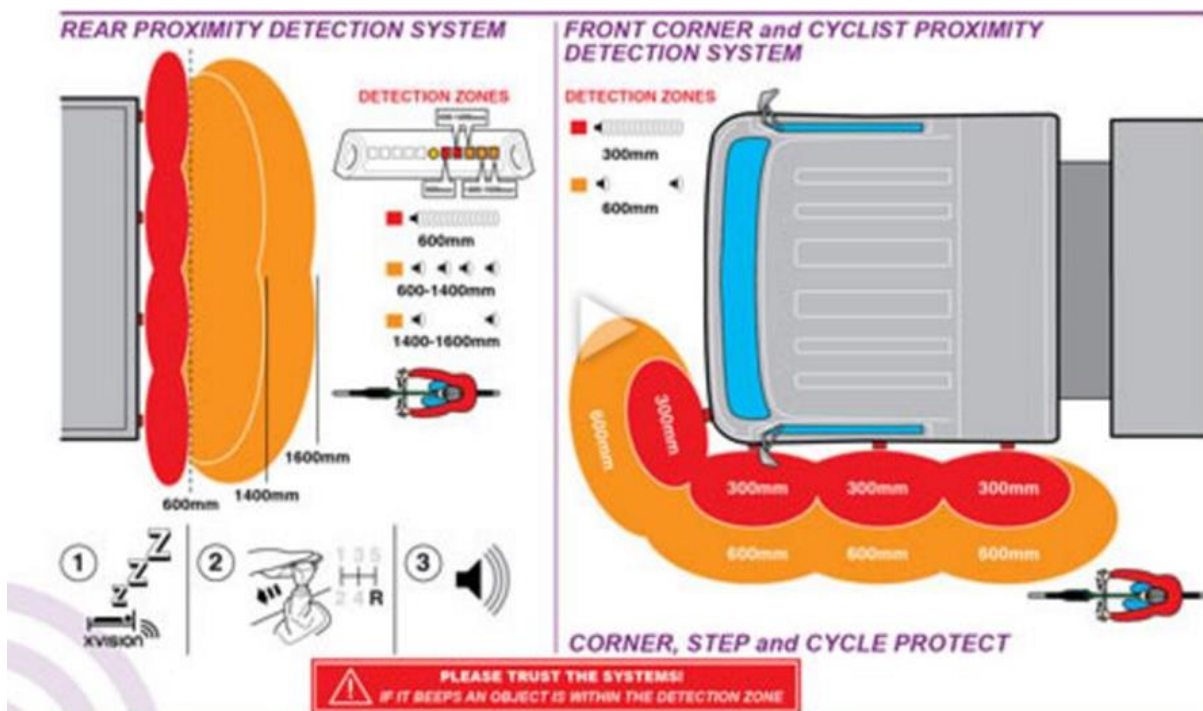
Vehicle Engineering: Blind spot detection system

Blind spot detection system is a technology that uses various sensors to detect the presence of vehicles or pedestrians in the blind spot area and warns the driver by providing visual and acoustic signals.

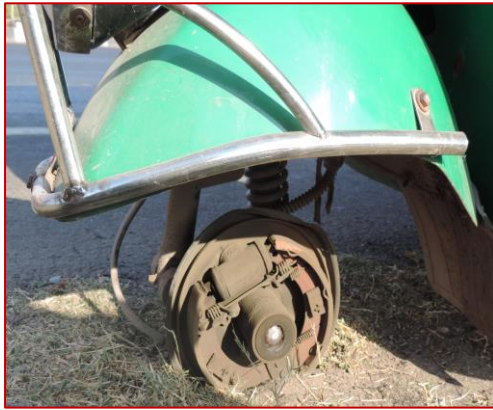
Defective Tyre - 1%
(1 M3W, 1 M2W)

Defective tyre is basically a collective term representing all sorts of tyre related issues (such as a broken hub, tyre burst etc.) that lead to crash. Tyres are the only part of the vehicle which are in

contact with the ground and therefore become the most crucial component while performing a sudden evasive maneuver. While definitive investigation of tyre bursts and defects require detailed tyre investigation, analysis and testing, which is outside the scope of this study, researchers were able to confidently identify two accidents where a defective tyre was the accident causation factor. Defective tyre includes any defect to wheel hub, rim and tyres. These kind of defects generally happen due to poor vehicle maintenance and overstressing the component until the point of failure.

Periodic maintenance of tyres such as tyre pressure monitoring, knowledge on recommended tyre pressure, tyre rotation etc. can enhance the life of tyre and prevent tyre failures. Prevention of overloading of vehicle can help minimize mechanical failures. Usage of tubeless run flat tyres can prevent sudden loss of vehicle control in an event of a tyre failure. Replacement of tyre is recommended over a tyre which has been repaired for punctures, multiple times. Traffic authorities must be trained to identify the conditions/ defects in a tyre and must advice the respective road user to perform corrective measures. General awareness among public on tyre care may also help resolve this problem.

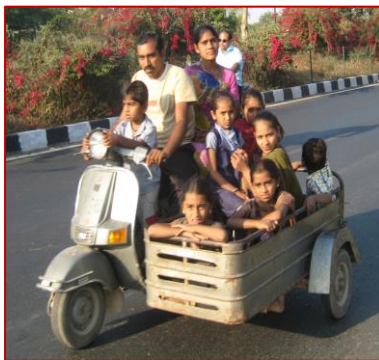
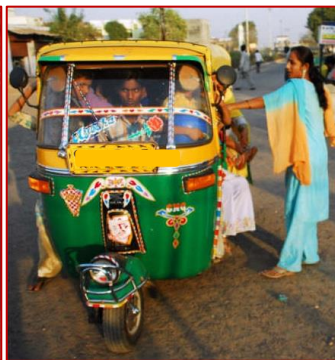
Overloading people - 1%
(2 M2Ws)

Overloading of people is a scenario where the number of occupants in the vehicle exceeds the seating capacity specified by the manufacturer. Overloading of people impedes the driver's ability to control and maneuver the vehicle as the driver's operating space is reduced. This leads to driver distraction as well. Overloading

increases the stresses on brakes and suspension drastically which eventually leads to reduced traction and failure of stressed components. This condition overloads the engine as well, reducing its life and efficiency.

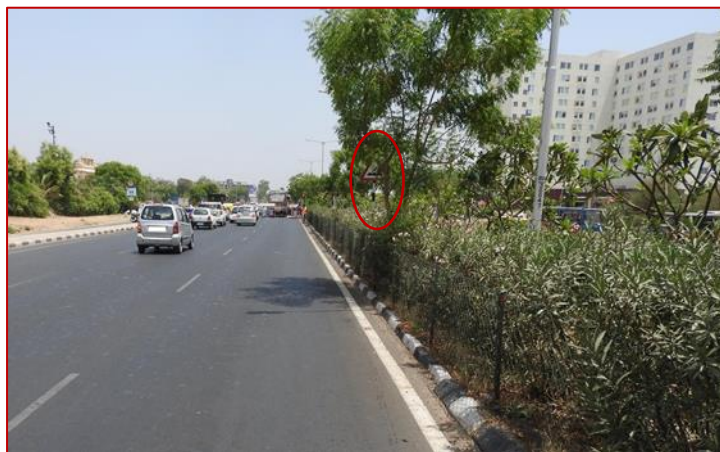
Poor road marking/signage - 14%

The purpose of road marking and signage is to direct and guide the road users, helping them to quickly decide what to do and where to go, all while negotiating traffic. If proper road signs and markings are missing, the driving environment becomes more dangerous. In the current study, this factor was determined to have contributed in 14% of the analysed accidents.

The ability of a driver to see, read, comprehend and make decisions are largely dictated by the placement, size, visibility and illumination of the signboards, which is a huge subject, and detailed discussion is beyond the scope of this document. However, often the problems are so obvious that most frequent road users are aware of them, and solutions to improve such problems of missing or misleading information are not difficult.

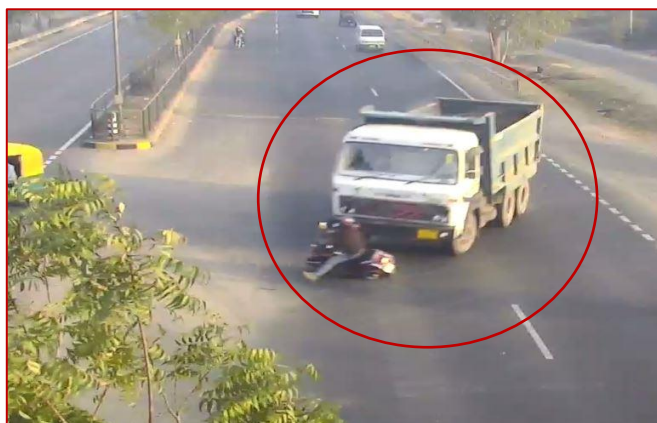
Poor intersection design – 7%

Crashes frequently occur where two or more roads cross each other, also known as intersections. Particularly if a district/local road crosses a National Highway, it becomes an accident prone zone. Activities such as crossing and turning left/right have the potential for conflicts among all road users, particularly when non-vehicular traffic is added to the mix, for example - pedestrian crossings. Good intersection design must

clearly indicate to all the road users how to traverse the intersection based on the desired direction the driver wishes to take. Intersections can be of different types like four way intersection, three way intersection, roundabouts etc. Intersections must be properly engineered with traffic signals, speed control devices, warning signs etc. In the current study, this factor was determined to have contributed in 7% of the analysed accidents.

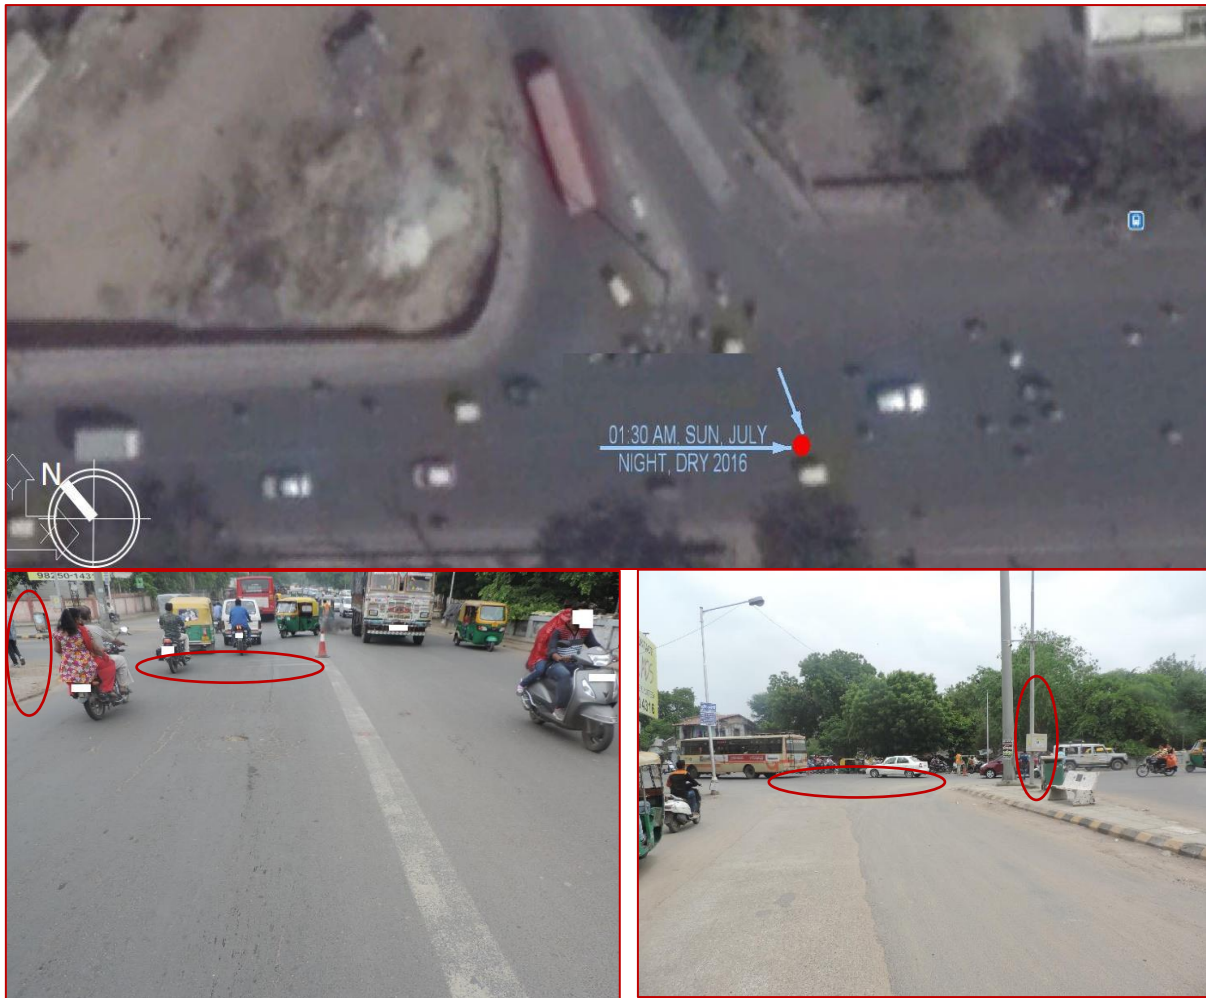
Accident date: 10/07/2016	Accident time: 01:30 Hours
GPS: 23.00706N 72.60948E	Accident location: Anupam bridge
Fatality Count: 1	Road structure: T Junction
Accident summary	
A truck was travelling towards east, approaching Anupam cinema T-junction from Anupam bridge. A motorized two wheeler (M2W) was travelling south, was also approaching the T-junction and intended to take a right turn to join Anupam bridge and travel further towards west.	
It is a misaligned, poorly designed intersection with absence of signage and speed control devices.	
The M2W rider misjudged the speed of truck and initiated the turn and, the truck driver who was travelling at excessive speed for the conditions couldn't react on time and had a front-side collision with the M2W. Post this impact the rider of M2W was run over by the truck and he died on spot. The truck driver suffered no injuries.	
Contributing factors:	
Accident factors:	Injury factors:

<ul style="list-style-type: none"> • Poor intersection design • Driver misjudgment for M2W • Over speeding for conditions for truck 	<ul style="list-style-type: none"> • Knock-down • Run over

Although there are other human related errors that contributed in the occurrence of this accident, lack of good infrastructure also contributed equally in the occurrence of the accident. Presence of speed control or traffic calming devices at the end of the downward slope of the bridge could have significantly seen a decrease in travel speed of the truck, thereby increasing the time interval to think and react appropriately. Presence of speed limit and intersection signage, and road markings such as yield lines could have better guided the M2W rider to perform a calculated turn maneuver and could have prevented this accident from happening.

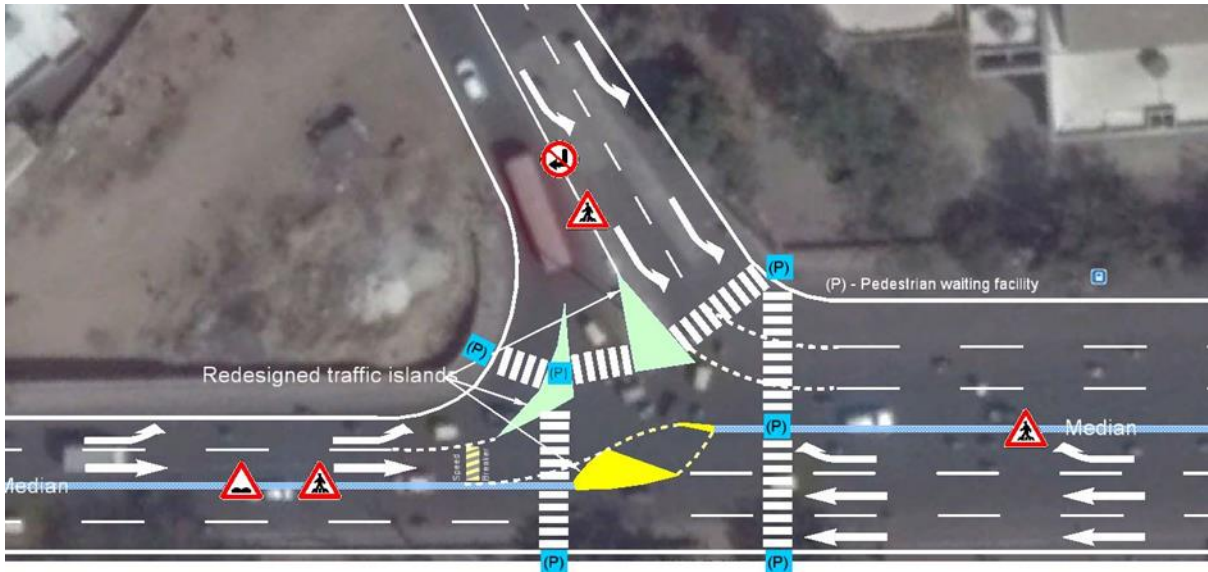
Figure 21: Design suggested by JPRI to overcome the problems faced in Anupam cinema junction

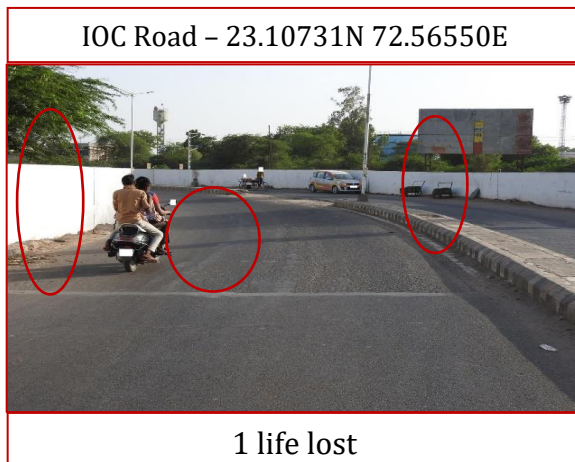
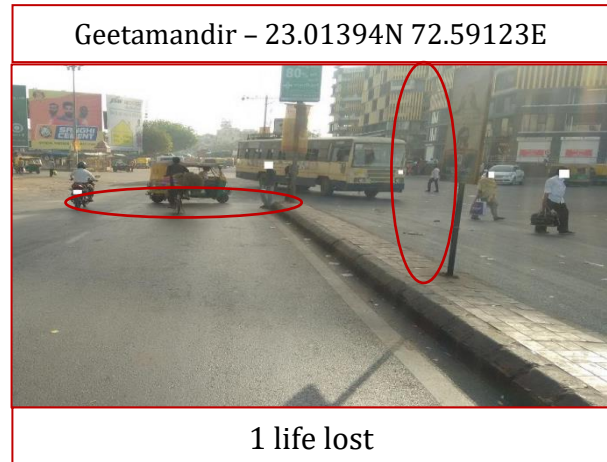
These are two more cases from our study where poor intersection design, Poor road markings/Signage contributed in Accident occurrence.

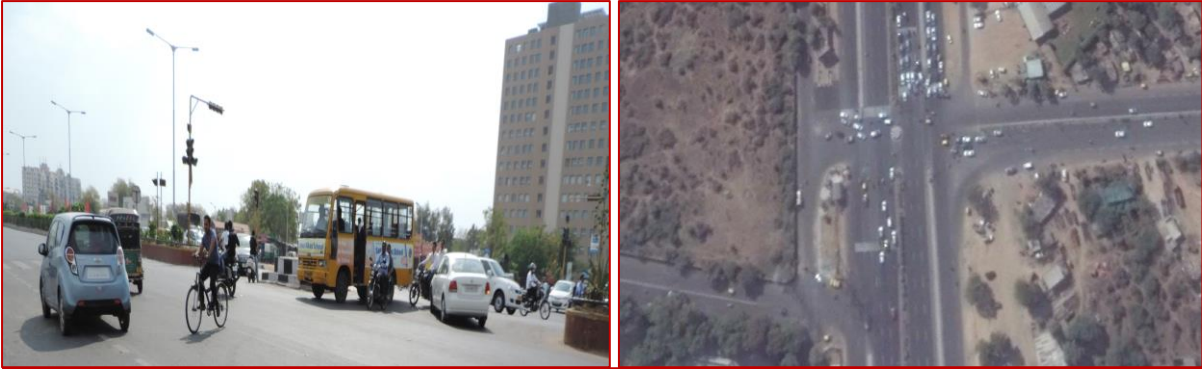
Ajanta circle

Misaligned four way intersection with no proper signage and inoperative traffic signal

A good four way intersection design must incorporate turning islands on all sides along with operative traffic signals and effective signage to promote safe and smooth traffic flow. This also stands as solution to problems like violation of right of way, traffic congestion at intersection etc. The key function of this design is that it denies exit/entry into the service lanes at the intersections. This design deviates the left turning traffic prior to the intersection, thus promoting a continuous traffic flow on the through lanes and encourages lane discipline.

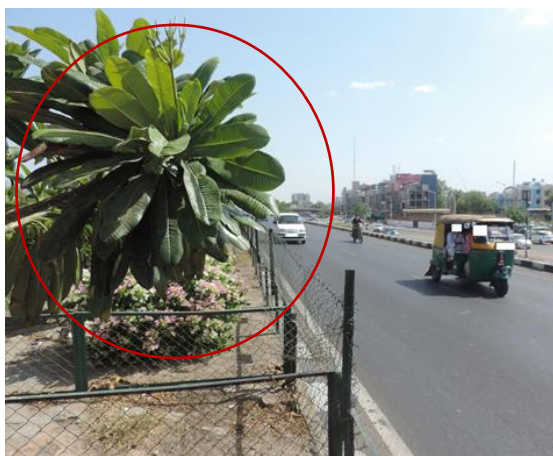
Vision Obstruction due to trees and plantations / manmade structures - 3%

Vision obstruction due to infrastructure is an obstruction created by any road feature that blocks or delays the road users from viewing each other thereby creating a conflict which may directly or indirectly influence the occurrence of an accident. Our study shows, in most occasion trees and plantations positioned on the median and road side obstructed the vision of the driver and contributed to the occurrence of accidents, followed by vision obstruction due to other manmade structures such as building, advertisement hoardings, work zone fencing etc.

Vision obstruction generally results in decreased reaction timing and distance as a result of delayed or non-recognition of a critical situation.

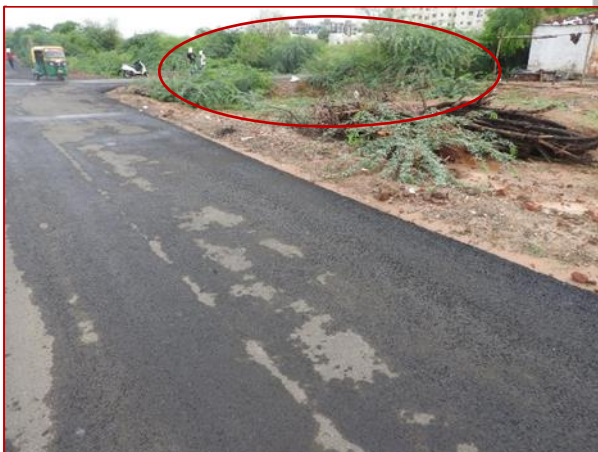
Both the vehicles had a vision obstruction due to trees and plantation and could see each other until the point of impact. The vehicles had a front-side collision which resulted in the spontaneous death of M2W rider. The driver of car was unhurt.

Motorcyclist's vision obstructed by plants

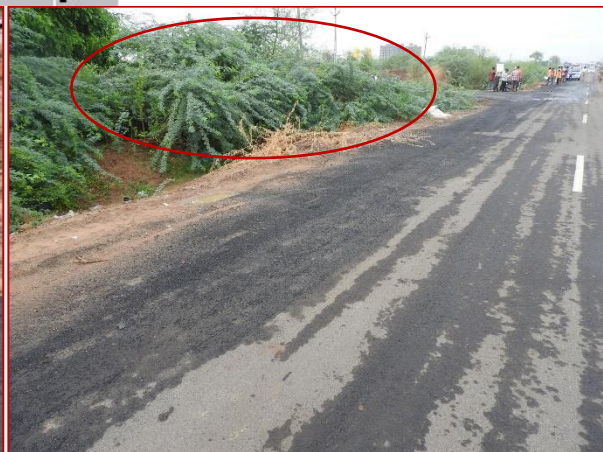
Car driver's vision obstructed by Plants

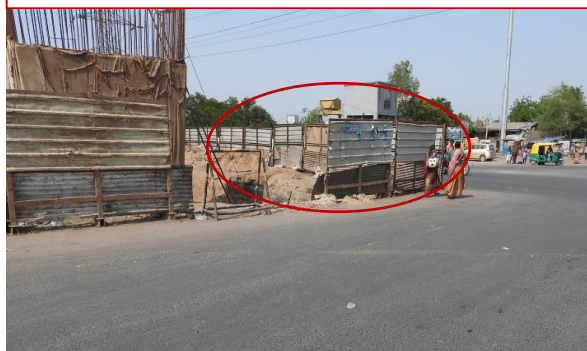
Odhav junction – 23.02489N 72.67307E

2 lives lost in 2 different accident

In the first location (Odhav junction) mentioned above, two different accident took place as a result of vision obstruction due to manmade structure – fence of a work zone. In the second location (S.P. Ring road near Odhav), presence of plantations on the median restricted the vision of the road users resulting in an accident.

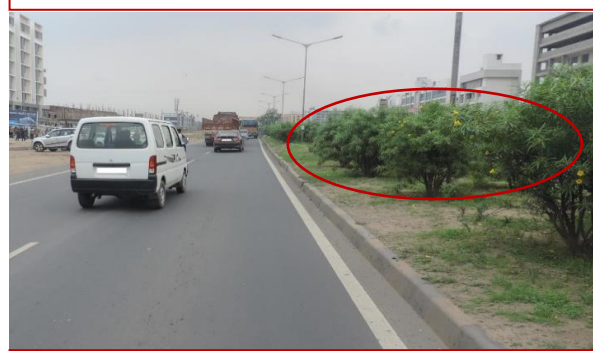
S.P. Ring Road – 23.00366N 72.66761E

1 life lost

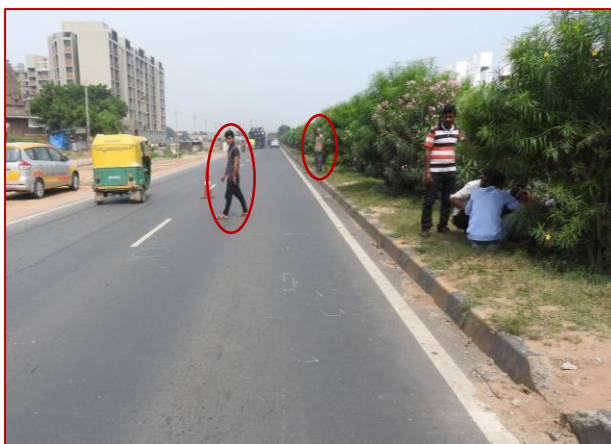
Inadequate pedestrian crossings - 5%

Inadequate pedestrian crossing means absence of pedestrian crossings or insufficient number of pedestrian crossings on a particular stretch of road where the pedestrian crossing density is somewhere between moderate to high. Inadequate pedestrian crossing facilities results in pedestrian, crossing or entering the road from anywhere, thus creating a potential safety threat to them and other fellow road users. This factor is many occasions also leads to pedestrian creating illegal openings

for them cross or access the road. This factor had its influence in 5% of the total 34 pedestrian accidents analysed in this study.

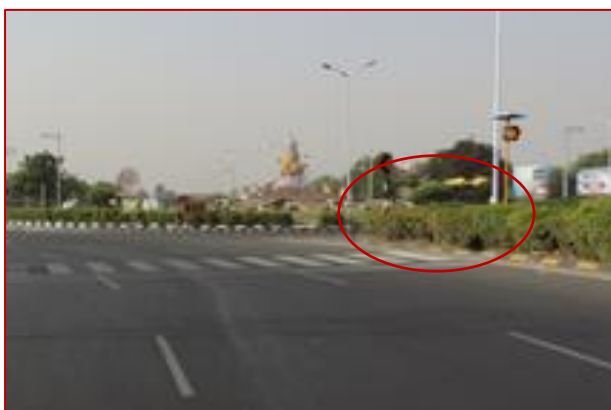
Poor pedestrian infrastructure crossing - 4%

A good pedestrian infrastructure consists of proper waiting facility for the pedestrians, signage indicating presence of pedestrian crossings, properly painted and maintained zebra crossings and presence of footpaths along the road. Absence of any of the mentioned factors results in an unsafe vehicle pedestrian interaction. This factor had its influence in 4% of the total 34 pedestrian accidents analysed in this study.

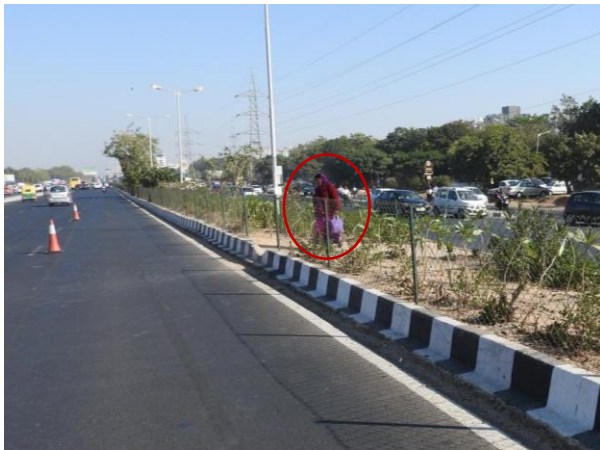
Illegal pedestrian crossing - 4%

Presence of inadequate and poor pedestrian infrastructure results in pedestrians creating illegal opening as per their convenience in many occasions as per the requirement. These are generally openings created on median or roadside barriers by tapering the basic structure of median or barrier. This is a serious issue because these openings were not a part of the planned road design and no other pedestrian infrastructural facilities will be available in that location like signage indicating presence of pedestrian crossing, and

often catches other vehicle users by surprise. This factor, in many occasion is also accompanied by vision obstruction, which again is a leading accident causation factor. This factor had its influence in 4% of the total 34 pedestrian accidents analysed in this study.

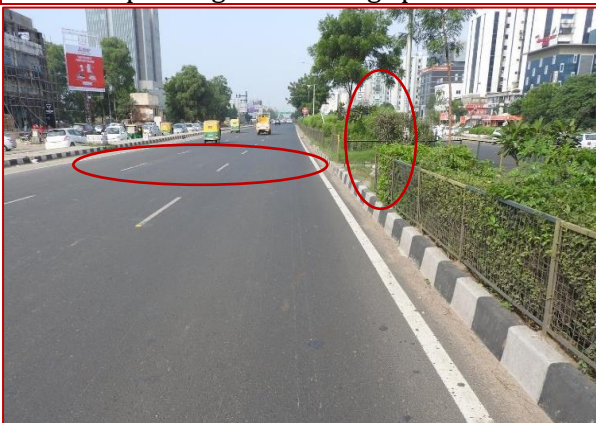
Accident summary:
 A Motorized two-wheeler (M2W) was travelling towards north-east (towards Gandhinagar) on SG highway while a male pedestrian entered into the road from right with respect to M2W's travel direction with an intention to cross the road.
 Road structure is a six lane divided road (divided by median with raised curb) with poor pedestrian infrastructure and poor pedestrian crossing facility.
 As the pedestrian suddenly entered the roadway, the motorcyclist who was travelling at high speed had no time to react and collided with the pedestrian. The pedestrian died on spot and the motorcyclist suffered serious injuries.

No signage - indicating pedestrian crossing

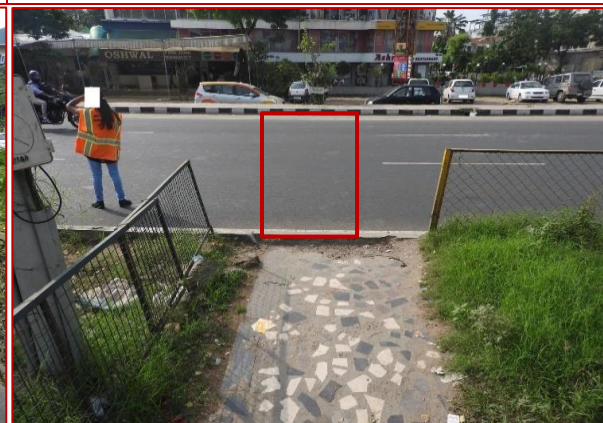
Absence of zebra crossing on road

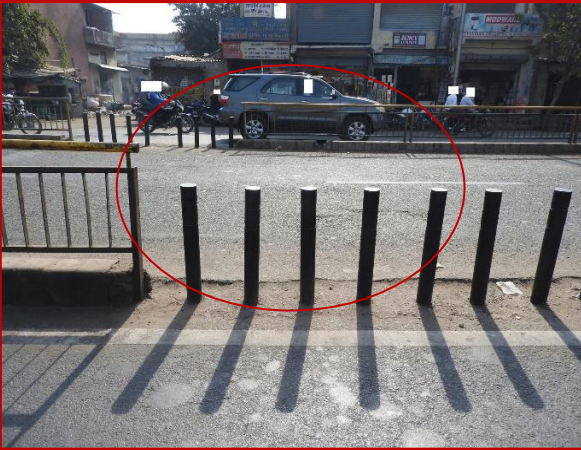
Naroda Road – 23.05472N 72.63163E

1 life lost – absence of cross walk and misaligned crossing

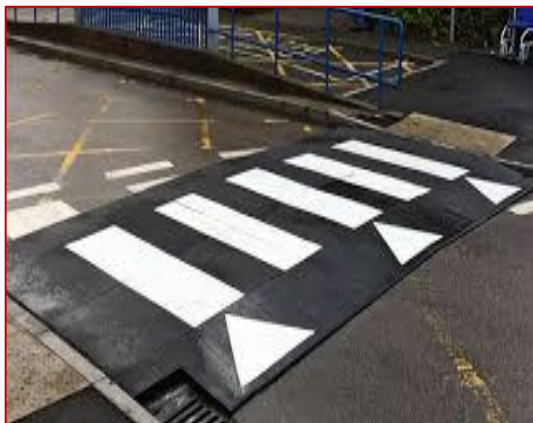
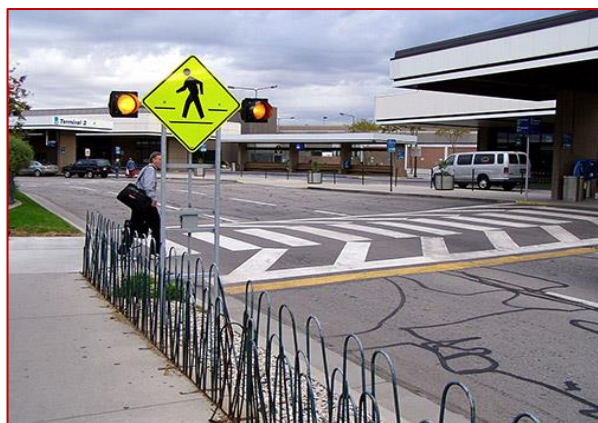
Infrastructural solution: Raised pavement pedestrian crossing

Raised pedestrian crossing or ramps is a hybrid solution which not only contributes to safe pedestrian crossing environment but also calms the vehicle traffic in that location. This feature compels the road user to reduce the speed of the vehicle irrespective of the presence of pedestrian, thereby enhancing the safety of that location in general. This solves distraction and inattention problems to a good extent. This has proved to be very effective in the western world and is most suitable in cases of junctions, intersections and other pedestrian populated areas such as school zones etc.

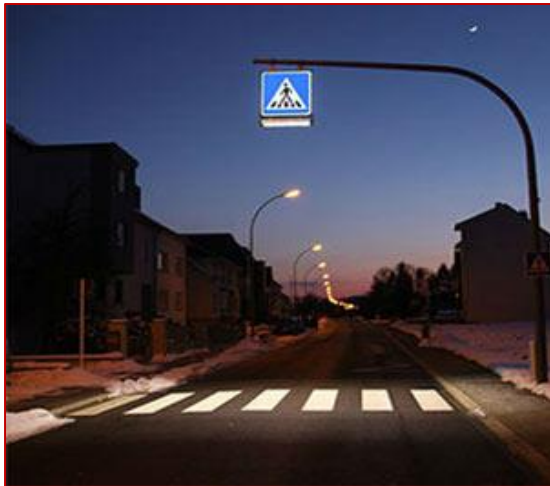
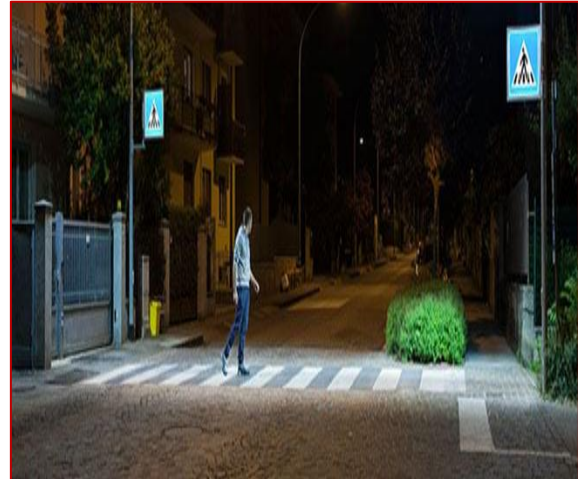
Infrastructural solution: Pedestrian crossing with illuminated Traffic Sign & Spot Light

The above system is specially designed for night time applications. Here the pedestrian cross walk is painted with light reflecting paint which works in sync with the flash light placed above. The light from the flash light or street light is reflected by the paint on the pedestrian walking on the cross walk, thus decreasing the conspicuity related problems to a great extent in night time driving. This system also houses an advanced mode where the presence or an approach of a pedestrian into the road is picked up by the radar signal, which in turn cautions the oncoming vehicles by activating the secondary flash light incorporated with the system. The secondary flash light keeps blinking until the pedestrian walks out of the detection zone. This also enhances the attentiveness of the vehicle users, thus reducing accidents.
