Ahmedabad Urban Road Accident Study 2016

Comprehensive analysis of 156 accidents examined between January to December 2016

JP RESEARCH INDIA PVT LTD
No.703, Sakar-3, Ashram Road,
Near Income Tax Circle,
Navrangpura, Ahmedabad - 380014
Gujarat, India.
Phone: +91-79-4007 7714/15/16

COMMISSIONER OF TRANSPORT, GOVT. OF GUJARAT
2nd Floor, Block No. 6, Dr. Jivraj Mehta Bhavan,
Gandhinagar – 382010, Gujarat

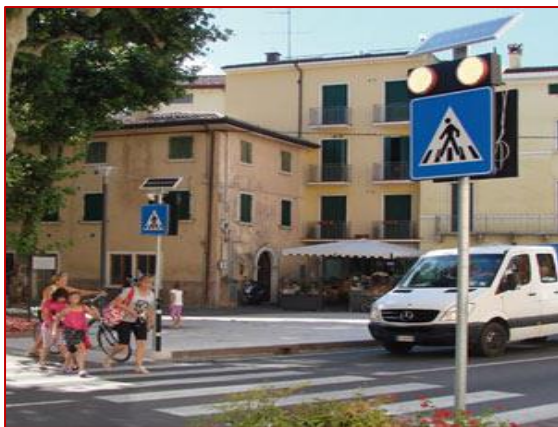
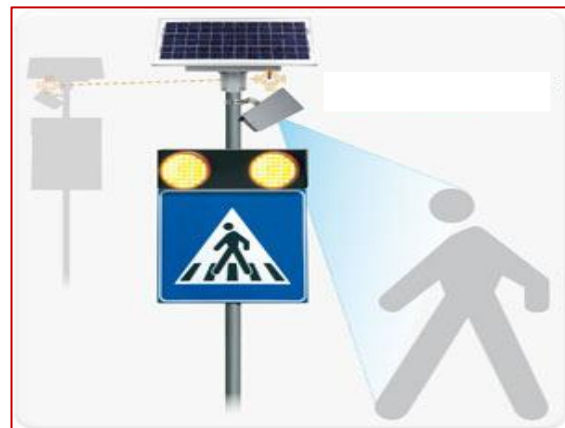
Infrastructural solution: Pedestrian crossing safety system with Radar & Flashing Lights

This solar powered system consists of different sensors which sends signals in the form of flashing lights to the vehicle users when a pedestrian is about to enter a cross walk. As soon as pedestrians enters into the detection area of this system, the LED lights starts flashing thus informing vehicles about the possibility of a pedestrian entering the roadway. This advance information cautions the road user to pay attention and reduce his travel speed, which eventually will result in smooth and safe vehicle – pedestrian interaction.

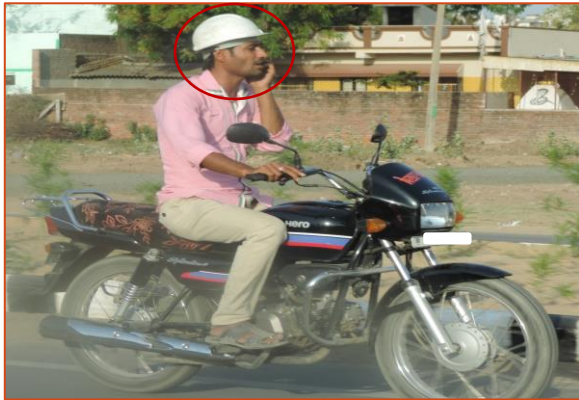
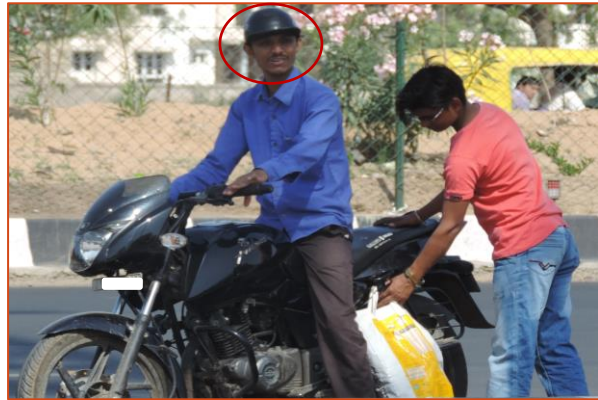
Helmet Quality is an Issue

Usage of substandard helmets may save some time and fine amount, but not one's life. Buying a quality helmet with a strong protective casing (full head covered is better than a half helmet or a hard hat) is a good first step, but riders also need to pay attention to the condition of the helmet. A helmet that has been in a crash is no longer fully protective, even if it "looks ok", and straps and buckles need to be fully operational. Clearly, any public education effort would have to also stress the importance of ensuring the equipment meets approved safety standards in *all* ways.

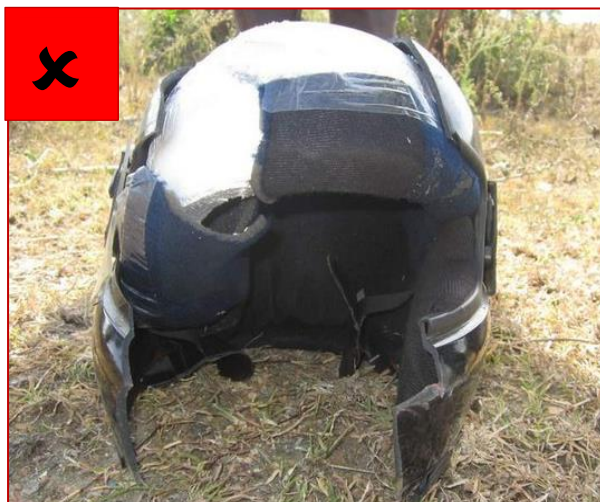
Damaged helmets found in few crashes indicates the use of sub-standard quality helmets.

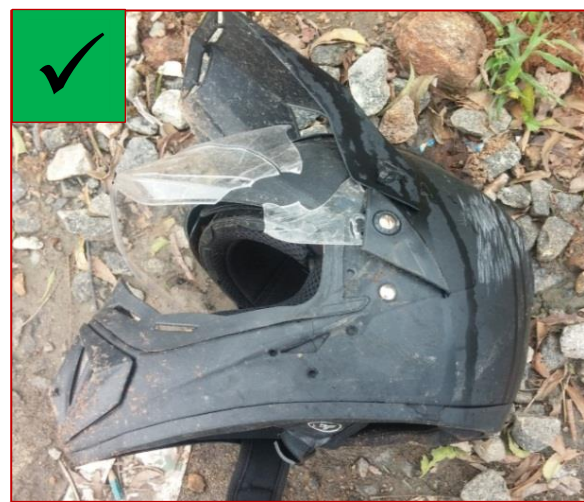
The more protection, the better! The chin guard was effective in preventing facial injuries to the rider.

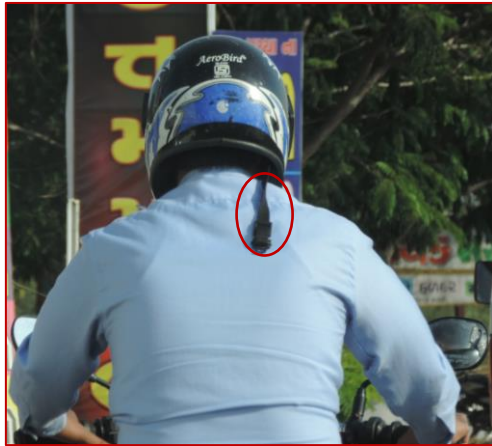
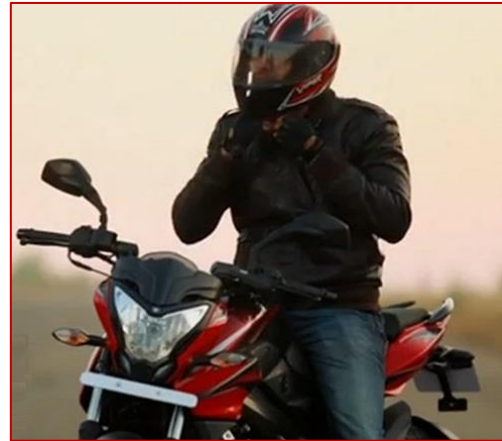
How Helmet is worn is Also Important

A helmet is not a cap to be worn slid off the back of the head, or fashionably unfastened at the chin. It needs to be the correct size and it should be properly fitted and fastened if it is to provide reliable protection in a collision. To bring awareness of the dangers of improper helmet use, public education campaigns are likely the only answer. However, much of this target audience is responsible enough to actually own a helmet, but independent enough to disdain being “told” facts about how to wear it (and why), so varied and inventive approaches may be necessary. Perhaps something such as a police-led campaign to hand out organ donor information cards to riders they see wearing a helmet improperly would get the point across: “If *you* don’t care about your vital organs, there is a waiting list of people who *do*,” etc.

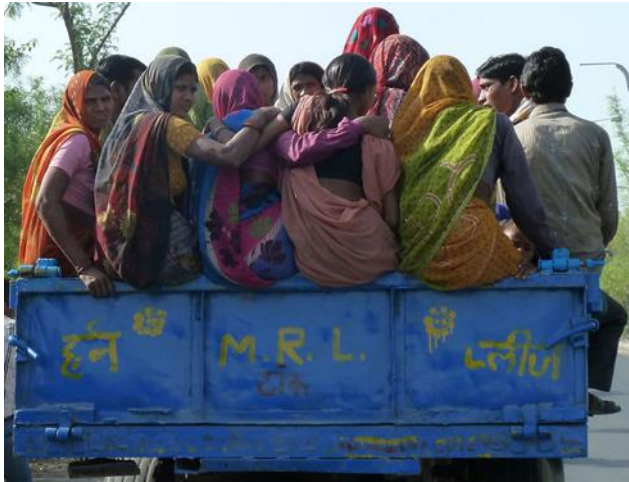
Occupants in cargo area - 3%
(2 Mini trucks, 1 M3W, 1 Tricycle)

It is a common sight in India to observe workers and farmers travelling on the cargo areas of Trucks, mini trucks, loading motorized 3 wheelers which is a very risky act to do. This becomes more hazardous for these people in an event of an accident. In most cases, these occupants go and impact themselves against the hard metal surfaces of the cargo compartment, or the cargo shifts and impacts these occupants as result of sudden deceleration. Ejection of occupants is also very likely to happen which often results in fatal or at least serious

injuries. This factor was observed to have contributed in injury occurrence in 3% of vehicles out of 146 vehicles in which travelling in cargo space is applicable.

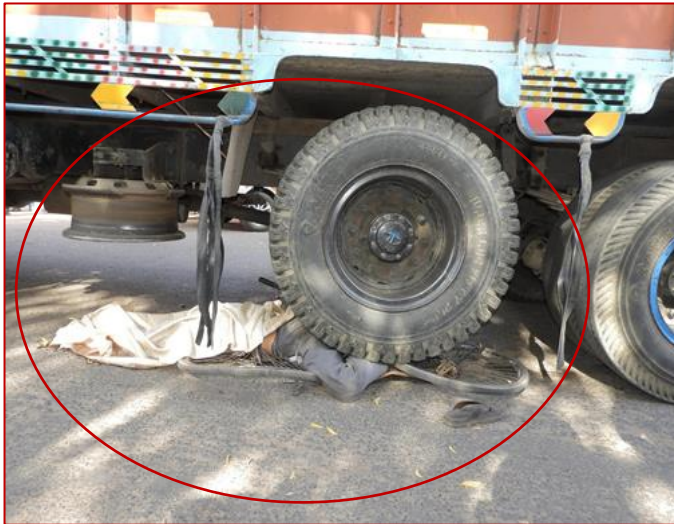
Run over - 40%

An accident which led to fatal or serious injuries as a result of single or multiple wheels of the vehicle travelling over any body part of an occupant or pedestrian is coded as a run over. This is often caused by vehicles which have high ground clearances such as buses or trucks where there is sufficient space between the lowest part of the vehicle's body structure and the ground for a road user to pass under the vehicle and reach the tyre. Although, trucks and buses are the most prevalent vehicles that cause run overs, it is not always

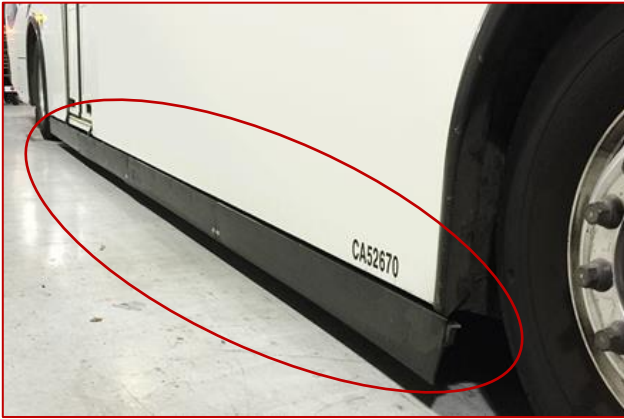
Danger zone barrier is again a run over prevention device which is similar to a side skirt setup that prevents or reduces the possibility of a person entering the under surface of the vehicle from the sides. Since it made of flexible material, these structures will be able to withstand impact from road obstacles as well

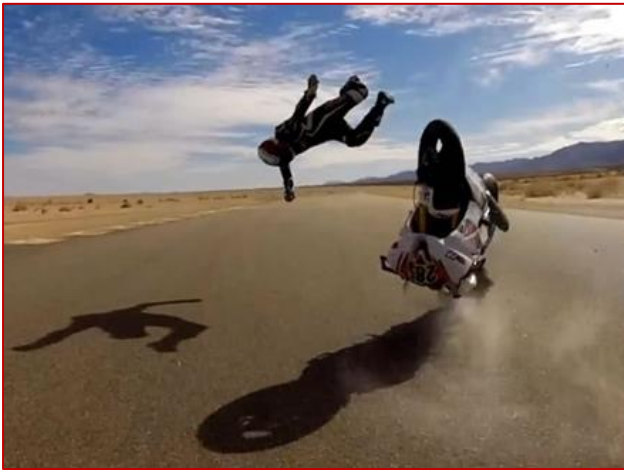
Fall down - 18%
(24 M2Ws, 1 Bicycle)

Fall down is a scenario where a motorcycle rider or bicyclist lost control of his vehicle, be it any reason like sudden braking or other avoidance maneuver (but not collision), fell down hard impacting against any surface, which resulted in fatal or serious injuries. This is limited only to motorized and non-motorized two wheelers because these are the vehicle types which can experience a self-fall as result of imbalance and instability.

There is as such no direct corrective or preventive measure to mitigate injuries during an event of a self-fall, but indirect precautionary measures such as usage of safety gear, road equipment with better impact absorbing properties can definitely prevent or at least reduce the severity of fall down related injuries. Educating road user about driving etiquette can also be a solution to reduce fall down conditions, so that road users should be courteous and stay alert while driving vehicle. Road users should follow lane discipline while driving as violating lane discipline leads to conflicts between vehicles which in turn leads to conditions of fall down.

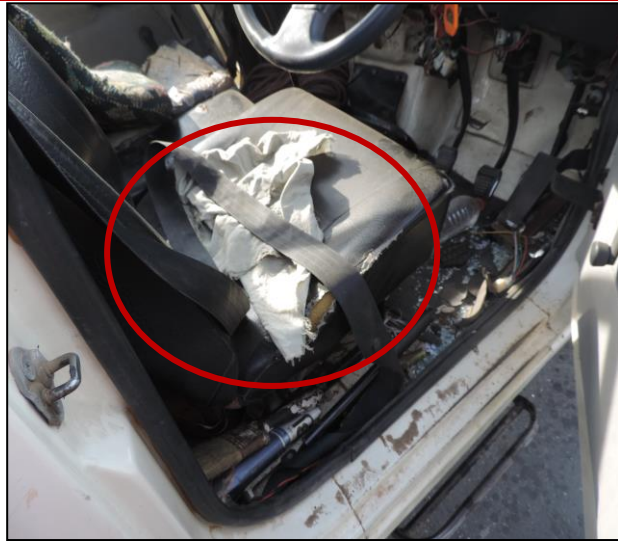
In almost every pickup truck in India, the seatbelt is either inoperative or not available

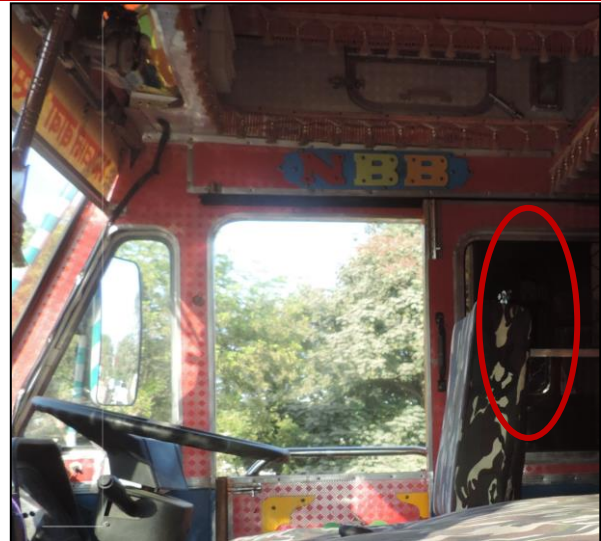
Almost every Indian truck has this issue – no seat belts at all

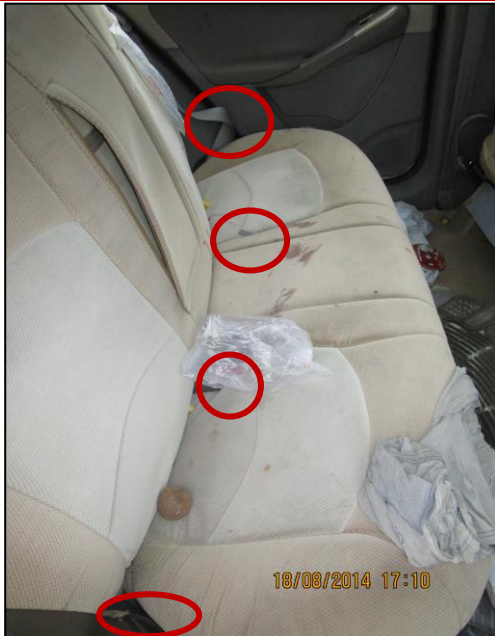
Although seat belts are present, people consider them a hindrance—so they hide the buckles

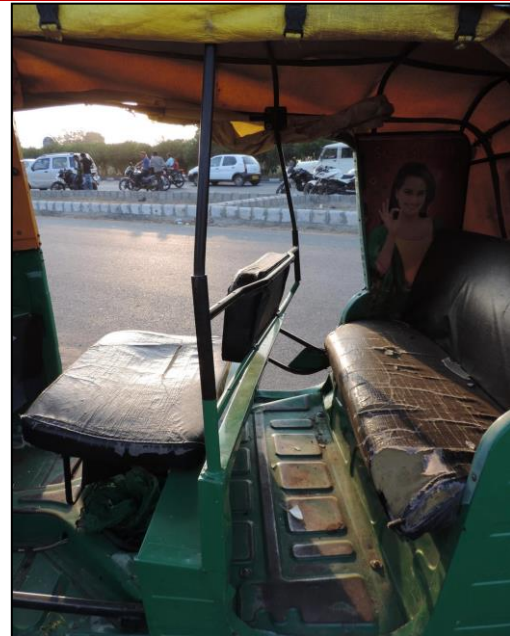
Auto rickshaws are vehicles that are not equipped with seat belts

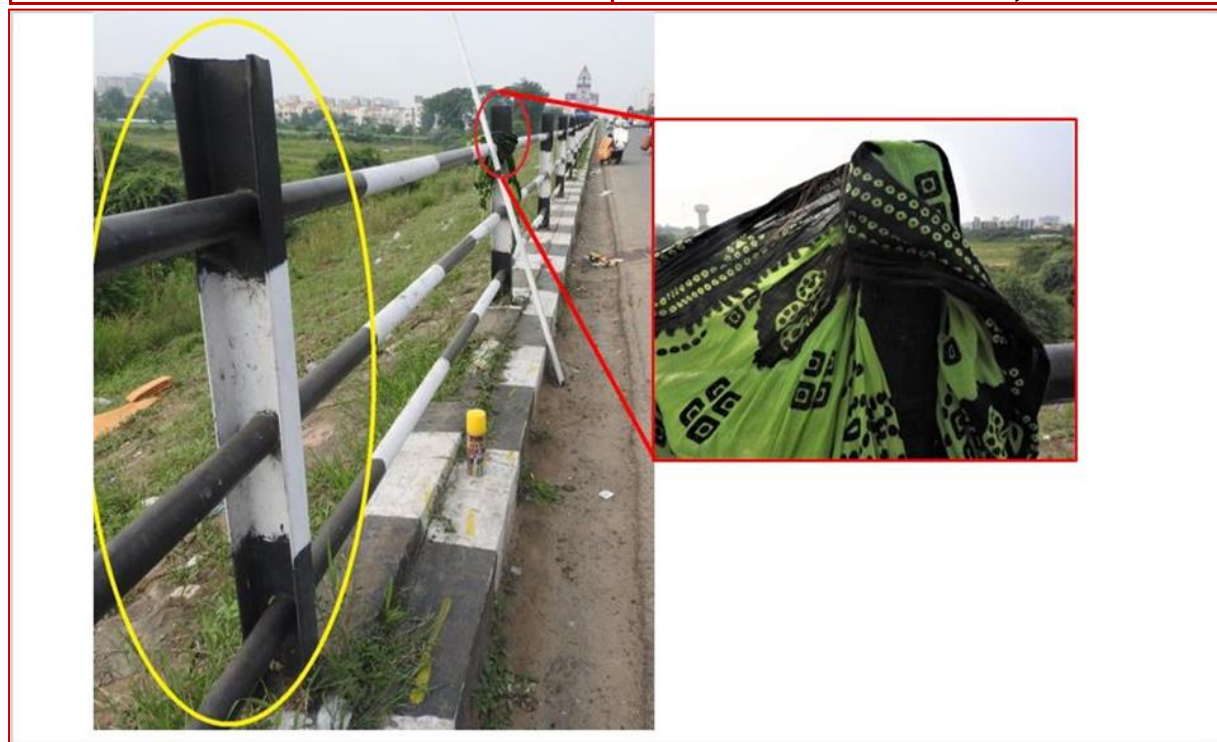
Accident date: 8/10/2016	Accident time: 13:00 Hrs.
GPS: 23.06286N 72.52113E	Accident location: Sola bridge, NH8C
Fatality Count: 1	Road structure: Divided straight road
Accident summary	
Two female non-helmeted occupants were travelling on a motorized two-wheeler (M2W) on NH8C towards Gandhinagar direction, when the rider of M2W who had no much experience in riding two wheelers, lost control of the vehicle, impacted the roadside metal barrier and fell down.	
The rider of the two-wheeler died on spot while the pillion rider sustained minor injuries.	
Contributing factors:	
Accident factors:	Injury factors:
1. Rider lost control due to inexperience	1. Helmet not used 2. Road side manmade object

In this accident, although both the riders travelling in the two-wheeler were not helmeted and, were subjected to similar amount of impact forces, the rider sustained fatal injuries while the pillion sustained minor injuries. This huge difference in the injury outcomes in spite of both the riders being thrown forward almost at the same velocity is because of the fact that the rider contacted against a sharp, non-yielding metal structure (metal fence) which instantaneously decelerated her resulting in critical head injuries, whereas in case of the pillion rider this impact was cushioned by the body of the rider of M2W (which is a better yielding structure in comparison) and the deceleration happen much progressively there by resulting in minimum injuries. Had there been a safe and proper fencing set up in that location at the time of accident, this accident probably might not have resulted in a fatality. So the real thing to be blamed in the death of the rider here is not the accident or not her inexperience in driving, but the poor infrastructural setup.

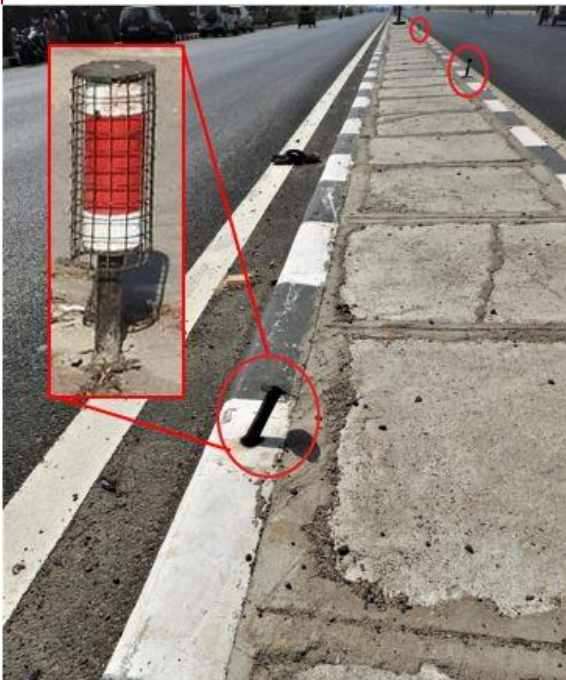
Thaltej underpass – 23.04285N

1 life lost

In all the above stated examples, although there are other human errors like non usage of helmet which contributed towards injury occurrence, unsafe and non-yielding infrastructural structure plays an equal role too. Presence of better and safer structures could have definitely made a significant difference in the severity irrespective of the usage of helmets.

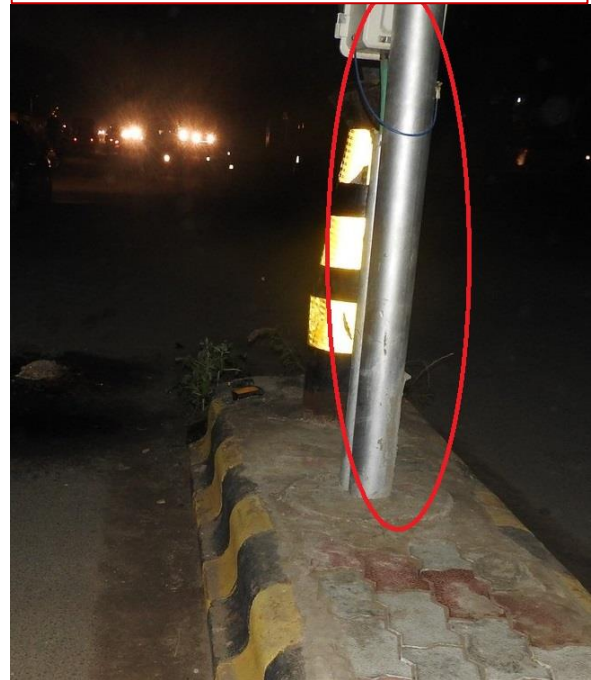
ITI Road – 23.08629N 72.64691E

1 life lost

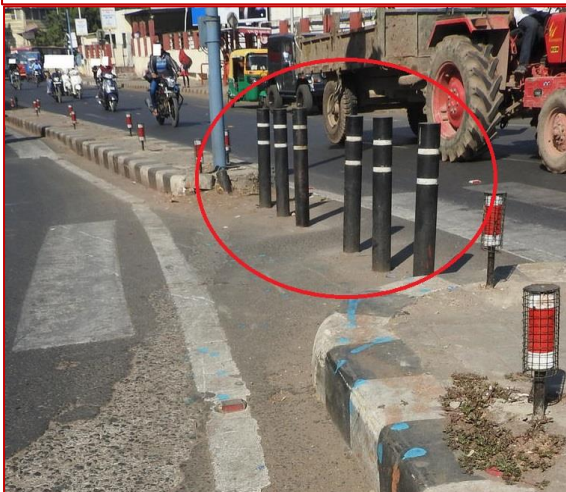
Kankaria Road – 23.00265N 72.59905E

1 life lost

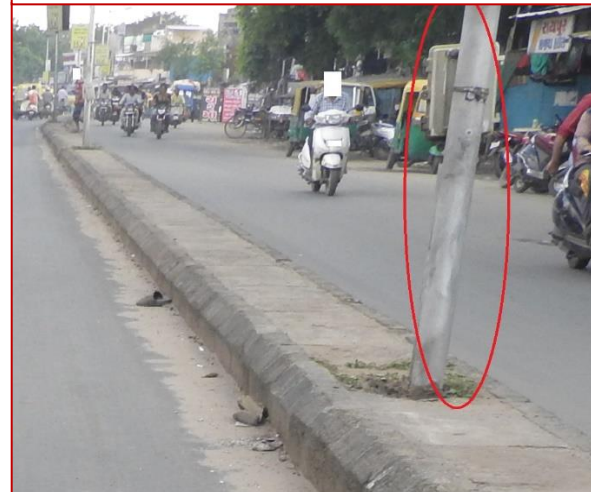
Narol Road – 23.00778N 72.580247E

1 life lost

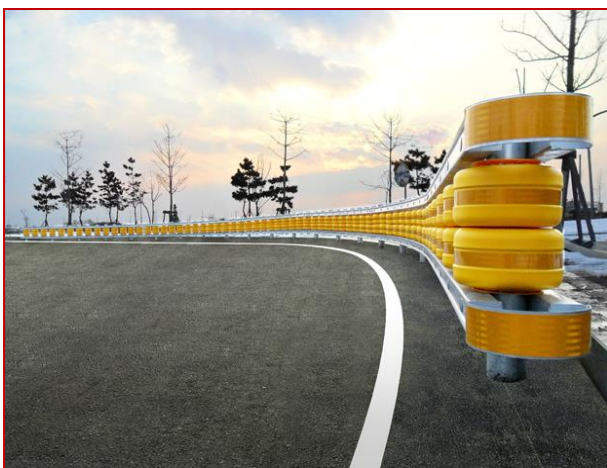
Infrastructural solution: Safety rolling barriers

This Safety rolling barrier can be installed at both side of roads, sharp curve areas, heavy traffic roadways, protruded sites, median strips etc. It is made of special compound which can act as a rigid structure in redirecting the errant vehicle back toward its original travel path without allowing gating, and can also act as a better yielding structure (when compared to concrete or metal) when directly contacted by occupants or pedestrians. It highly enhances the safety of both the vehicles and its occupants by

converting linear impact energy into rotational energy which will result in progressive deceleration. Since multiple individual components make up this structure, it is easy and cost effective in terms of maintenance.

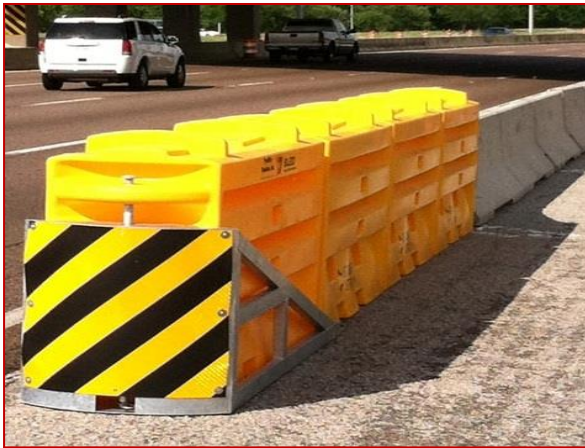
Impact attenuators are primarily designed to absorb the impact of a frontal collision with minimal damage to the structure it is protecting and the vehicle which is colliding. Some function like crumple zones in a vehicle, others offer a more resilient resistance, keeping their ability to protect even after they have been impacted. This basically absorbs and dissipates impact forces in a progressive fashion thus cushioning the vehicle and its occupants from impending forces.

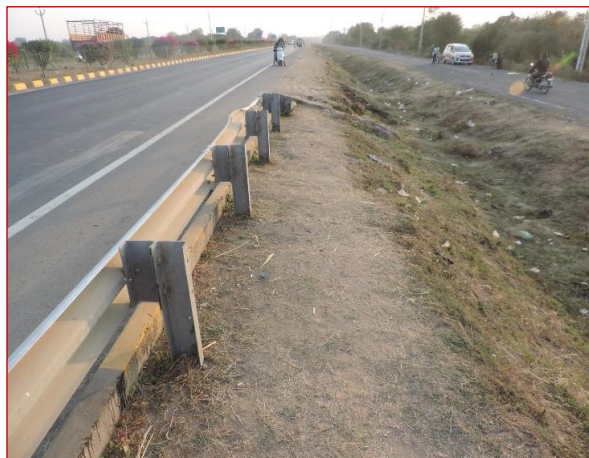
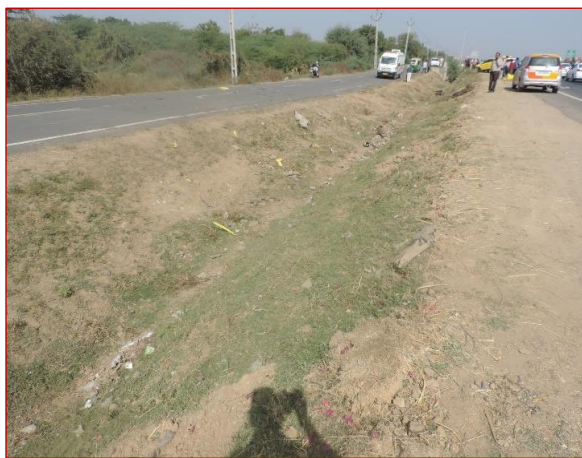
Accident date: 26/12/2016	Accident time: 00:45 Hrs.
GPS: 23.07328N 72.48844E	Accident location: S.P. Ring Road
Fatality Count: 2	Road structure: Straight road
Accident summary A car with four occupants was travelling towards north on S. P. Ring road. The road structure is a four lane divided straight road with ditches on either side separating the main roads from service roads. As a result of over speeding, the driver of the car lost control over the vehicle, went off the road to the left side and fell into the ditch on the road side. The car landed hard on its nose, travelled a few meters inside the ditch and stopped finally after climbing over the guardrail. The left side occupants of both front and rear rows sustained fatal injuries, while the right side occupants of both the rows suffered serious injuries.

Contributing factors:	
Accident factors:	Injury factors:
1. Speeding-Excessive speed for condition.	1. Seatbelt not used 2. Roadside steep slope/Drop off

Even though there are other human factors like non usage of seatbelts that could be blamed for the injuries sustained by the occupants, the presence of unprotected road side ditch also played a significant role in injury occurrence. The car which fell into the ditch landed hard on its nose, transferring a tremendous amount of force inside the occupant's cockpit. The ditch here acted like a rigid wall almost yielding nothing, the car and its occupants were subjected to very high deceleration over a very small period of time which resulted in the occupants suffering critical and fatal injuries. A proper ditch design should incorporate a run-off area so to decelerate and regain vehicle control. In any situation, it should never allow rapid deceleration to occur. It must always be protected by guardrails on both the sides. Had there been a proper guardrail positioned in that location, it might have absorbed a lot of impact forces and would have probably deflected the vehicle back towards the road, or in the worst scenario could have at least led to a considerably soft landing car, which could have resulted in a less severe injury outcome. Ditch should be provided with proper run-off area to decelerate the vehicle gradually and gain the control back on the vehicle.

Predominantly, manmade objects placed on roadway, median, etc. must only serve the purpose of crash protection and road delineation. Any other manmade structures serving other vital purposes must be made crash friendly and forgiving. It is always safe to have roads without the presence of ditch or slopes, unless it serves a very essential purpose. In such cases the ditch design must not be steep or uneven.

Well engineered crash barriers must be added to the roadway, particularly on roads having a ditch or slope on its sides. The bridge walls must be crash friendly and tall enough to avoid tipping or fall of the vehicle. Crash barriers, irrespective of its type, must deflect and guide the vehicle back towards the road while keeping the level of damage to the vehicle, its occupants and the barrier at a minimum level. Ideally a crash barrier should present a continuous smooth face to an impacting vehicle, so as to slide over it without overturning. It should also be strong enough to withstand and absorb the impact forces. A good barrier design must always account for a slow and progressive deceleration. Advance barrier systems such as multilayer guardrails or composite guardrails uses materials of varied strength, positioned one behind the other so as to keep the deceleration levels low, which eventually reduces the severity of the injuries sustained. The crash barriers fitted in city roads must be designed in a way to accommodate vehicles of varying speeds and masses (from scooters to heavy duty trucks).
