# Kolkata City Accident Study

***Analysis of 868 Police reported crashes from January 2018 to December 2018***

JP RESEARCH INDIA PVT LTD  
3rd Floor, Kovai Towers,  
44A, Balasundaram Road, P N Palayam,  
Coimbatore – 641037, Tamil Nadu, India.  
Phone: +91-70446 39376

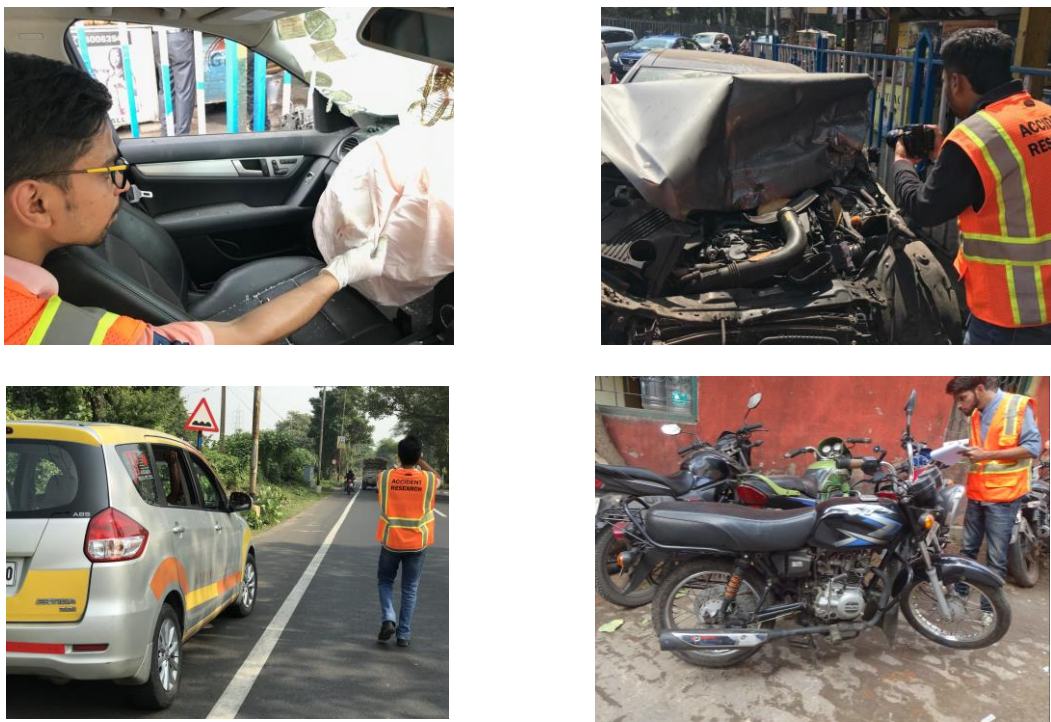
FIGURE 4: CRASH INVESTIGATIONS BEING CARRIED OUT BY JPRI CRASH RESEARCH TEAM

JPRI research teams spend considerable amount of time examining road crashes. In-depth crash investigations are conducted in a scientific manner involving detailed examination of the crash

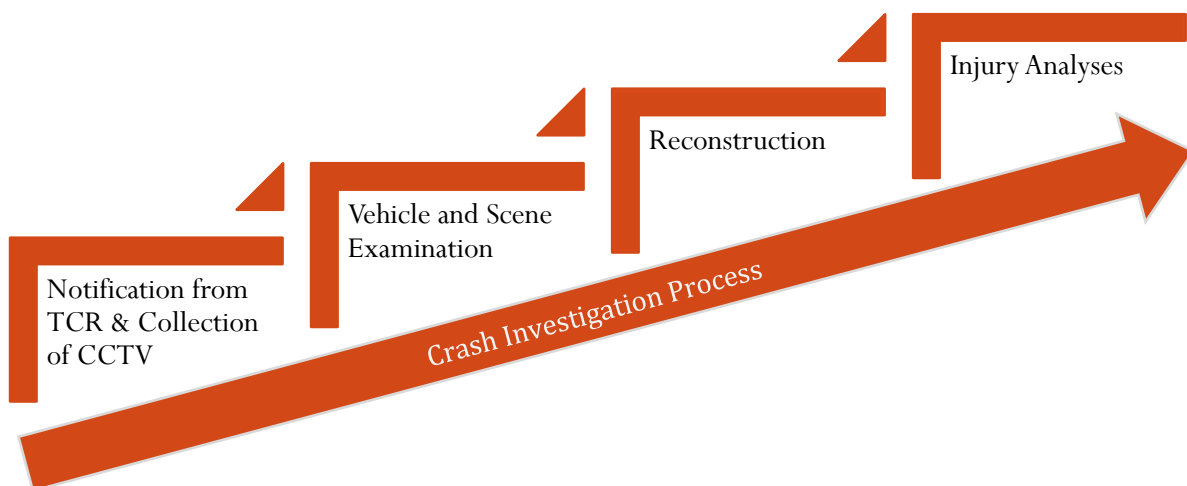
FIGURE 5: JPRI METHODOLOGY OF CRASH INVESTIGATION

Every morning, TCR notifies JPRI of all fatal and injury crashes in the study area that occurred on the previous day. On receiving the notification, JPRI researchers evaluate the data provided in the notification and based on a selection criteria, decide on the list of crashes that can be scientifically taken up for investigation. The basic criteria to be met for a crash to be investigated by the JPRI researchers include; 1. Crash must involve at least one motorized vehicle and 2. Crash spot has to be on a public road within the study (with Kolkata city jurisdiction). In addition, other details such as crash spot has to be identifiable by knowing the final rest positions, vehicle trajectories, other evidences. After taking up the case, JPRI researcher will collect the CCTV from TCR, if available, and then reach the crash scene to examine the scene evidence and inspect the involved vehicles. Vehicle inspection is done at crash scene or police station, wherever the vehicles are available.

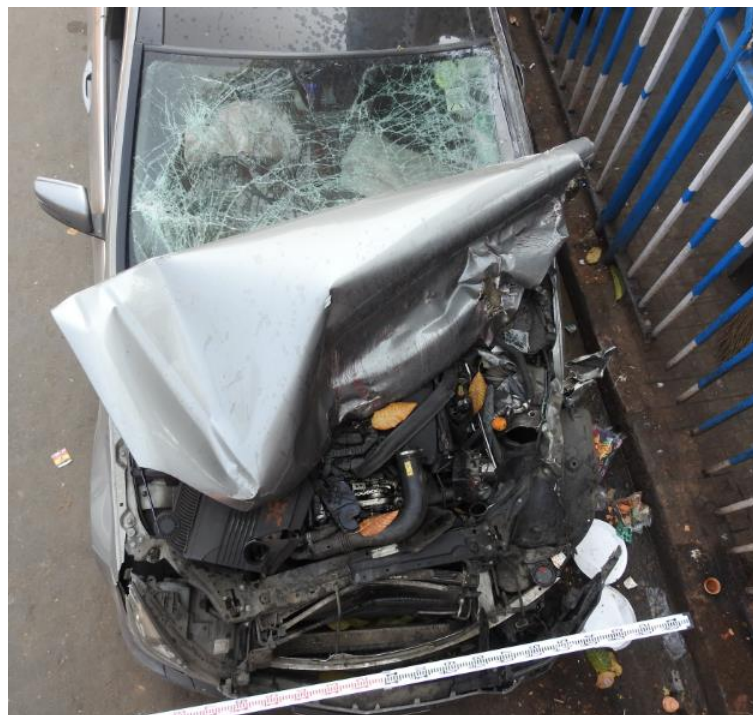
FIGURE 7: VEHICLE EXAMINATION AT POLICE STATION

Crash vehicles are examined at the crash scene, if available on spot, or at the police station if the vehicles are towed away. The exterior parts of the vehicle are examined to ascertain the impact and damage profile (direct and indirect). These values are required for determining other properties of impact such as collision severity (e.g., delta-V, EES). Finally, where possible, each impact is correlated to the impacts on the collision partner. The impacts are examined for evidence, such as paint transfer or deposited debris (e.g., metal, tree bark, graze from contact with a solid object), that can confirm such correlations. Road user contacts (e.g., motorcycle riders, pedestrians) on the exterior surface of the vehicle are recorded on a vehicle outline sketch.

The interior of the vehicle is examined to identify any intrusion into the passenger compartment, any occupant contacts with the interior components and structures, any use of and deployment of safety systems such as seat belts, pre-tensioners and airbags. The intruding component is identified and the reduction in occupant space in any of the 3 axes (longitudinal, lateral or vertical) is determined. Deformation of structures due to loading from occupants and interior occupant contacts are used in identifying the occupant kinematics during the crash. Airbags and seat belt components (webbing, pre-tensioners, etc.) are also examined using well-established methods to ascertain whether they have been deployed or used by the occupant. Finally all views of the vehicle, the damage locations, occupant contact evidence and any salient points on the vehicles and collision partners are photographed.

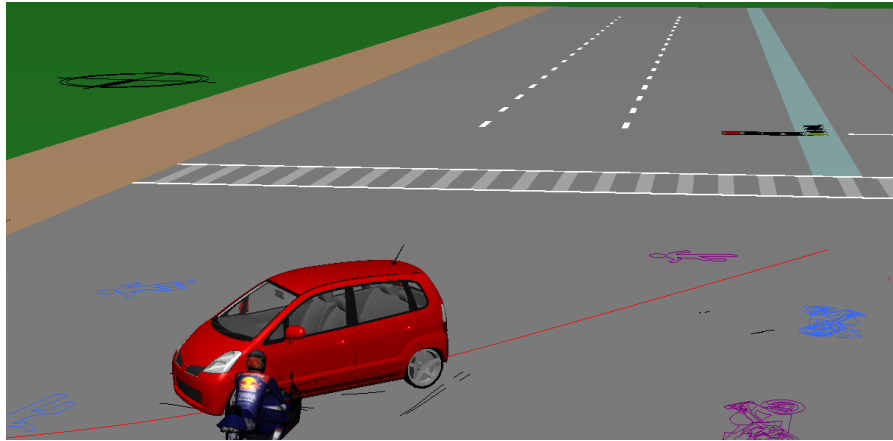
FIGURE 8: 3D VIEW OF CRASH RECONSTRUCTION

Based on the obtained evidence and information, Newtonian laws are employed to obtain the speed of the vehicle at the point of impact. In the absence of reliable evidence on the scene or vehicles, CCTV footage is used to calculate the speed. For complex cases, reconstruction is done using a software named 'PC Crash'. A snapshot of 3D reconstruction is shown in Figure 8.

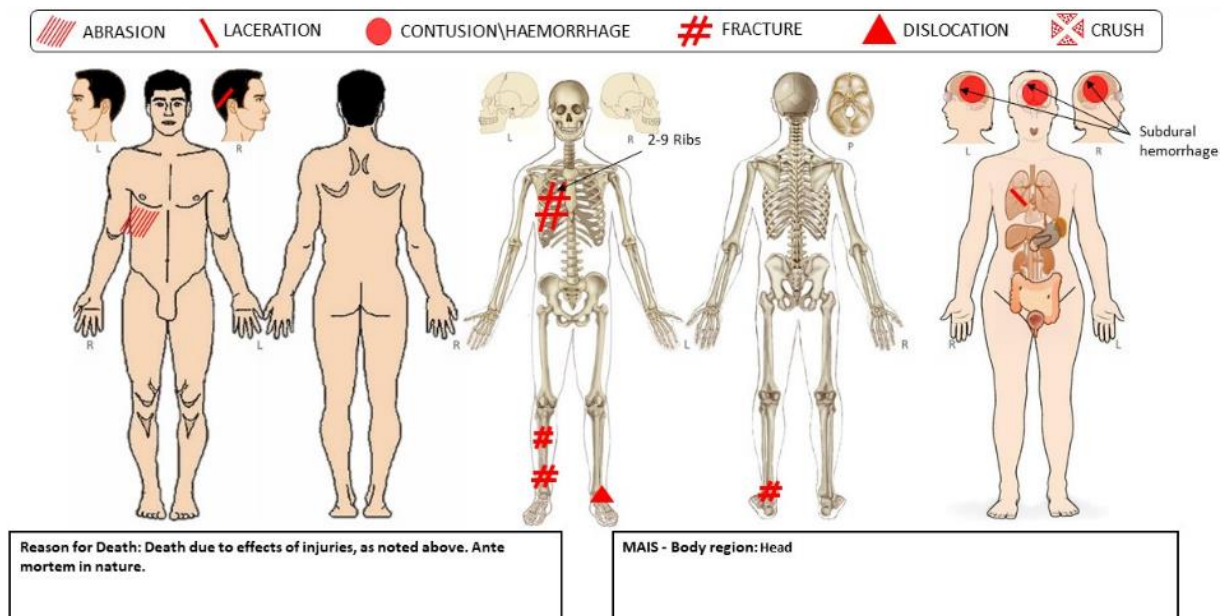
FIGURE 9: INJURY SKETCH SHOWING DETAILS OF OCCUPANT'S INJURIES

For all the crashes investigated in-depth, injury reports are collected to analyze the injury details of the affected road user.

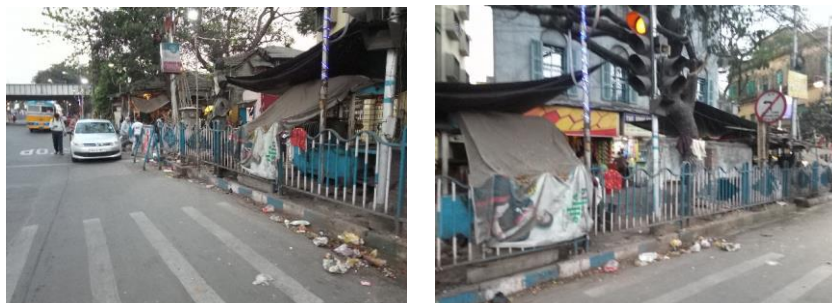
There are more than a few impediments in making the well-planned base infrastructure effective/friendly to use and reduce crashes. The most common concern noticed in the city is access to the pedestrian crossings. Example, Figure 23 shows a typical junction where the access leading to pedestrian crossing is completely closed. Over a period of time, such unusable access points affect the pedestrian behavior and encourages jay-walking exposing pedestrians to traffic.

Obstructed pedestrian access points rendering the pedestrian crossing useless.  
(Rabindra Sarobar North side crossing)

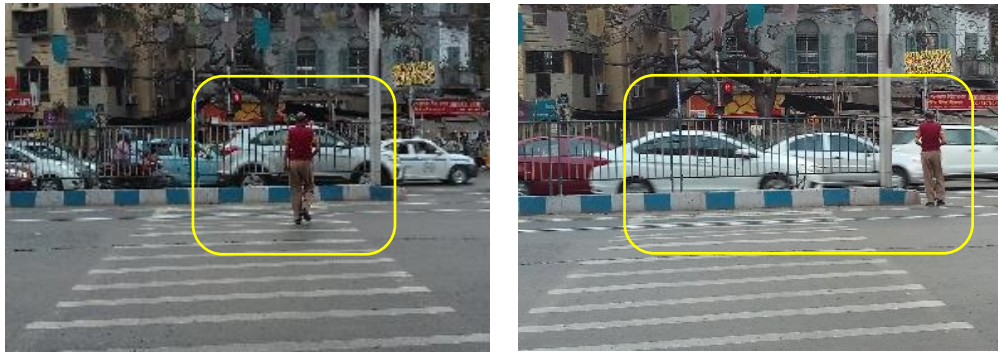
Lack of pedestrian refuge spaces compound the dysfunctionality of pedestrian facilities. One of the primary user characteristics that the IRC 103 2012 observes, *“The feeling of being secure is the most important governing factor. A pedestrian should feel safe during the day as well as the night while using a footpath / cross walk.”* The standard also mandates the usage of refuge islands on roads with more than 4 lanes or lanes with opposing traffic movements. Most important roads in Kolkata are 4 lanes or more but with no refuge islands.

A pedestrian who follows the traffic situations by using the zebra crossing is pushed to wait unsafely against the traffic (Rabindra sarobar North side junction)

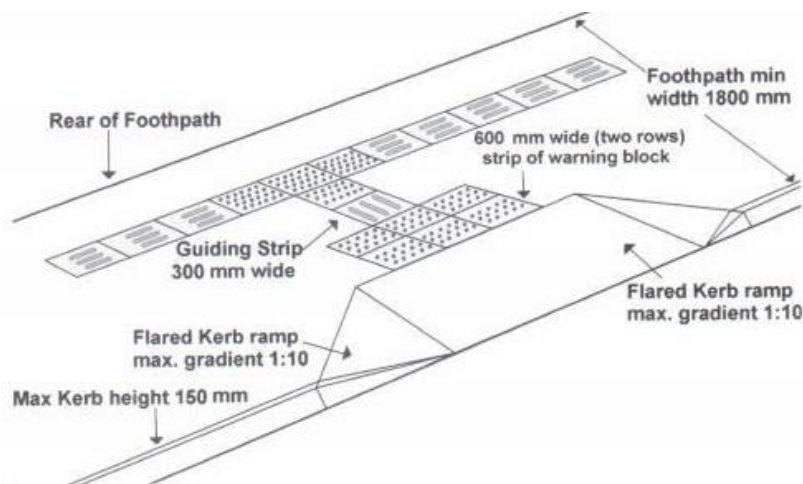
FIGURE 25: FOOTPATH DESIGN AS MANDATED BY IRC 103 2012

Adding to the dysfunctionality is the unavailability of drop kerbs. IRC 103 2012 mandates a maximum kerb height of 150mm with drop kerbs wherever a pedestrian crossing is to be facilitated. But almost all footpaths in Kolkata are more than 150mm with no drop kerbs in place. The aim of the drop kerbs is to be disabled-friendly and streamline the pedestrian flow in urban areas. The drop kerbs, despite providing easy passage by all users, also aids in encouraging proper usage of pedestrian facilities thereby reducing jay-walking.

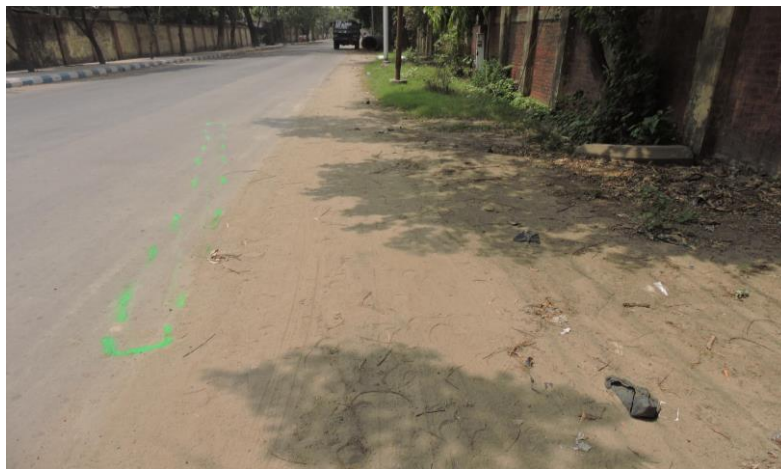
FIGURE 26: POOR PEDESTRIAN INFRASTRUCTURE - WALKING ALONGSIDE

Besides the availability of pedestrian facilities in most places, there are still quite a few places lacking dedicated pedestrian footpath. A few of the many locations, having inadequate pedestrian crossing infrastructure in Kolkata city, is shown below:

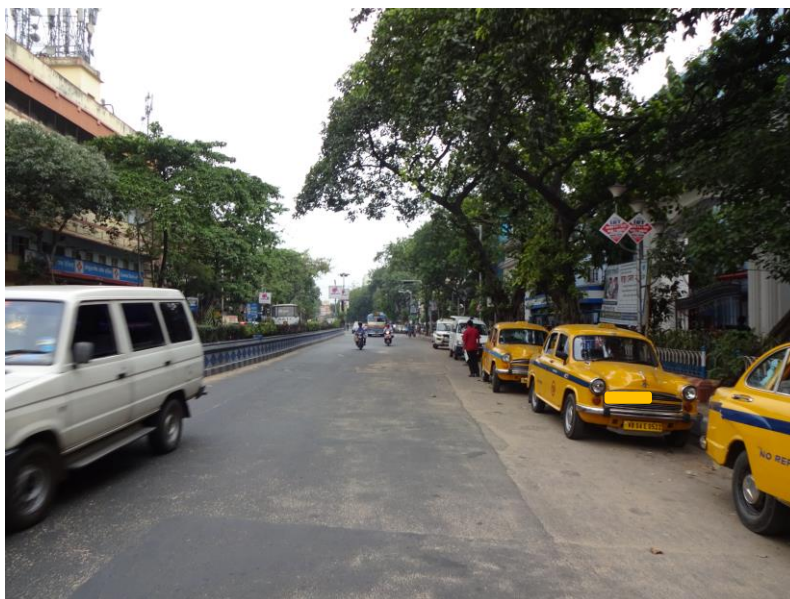
FIGURE 29: IMPROPER ROAD MARKINGS – KOLKATA SAMPLE

The most noted concern with regards to road marking is the design and materials used. The road marking designs are mandated by IRC 35 1997 including the materials and the colour. Road markings in Kolkata are done using non-standard paints that wear out easily. Also the length and the continuity needs attention. Lane markings are by far the most underestimated safety feature of a road. The markings influence the behaviour of the driver in a significant way and hence need to be properly invested and maintained.

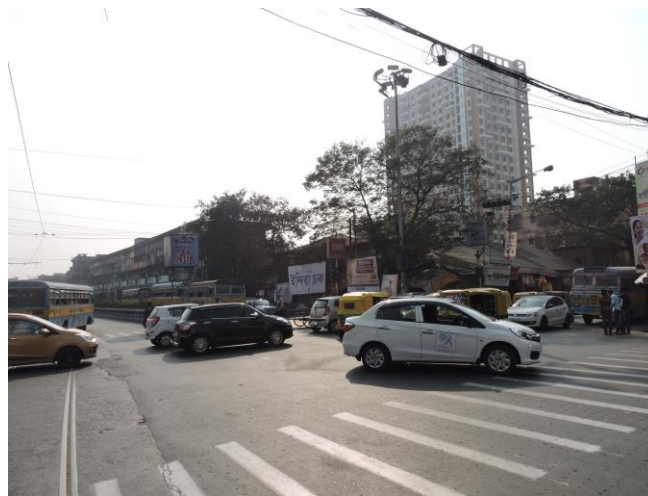
FIGURE 30: WIDE AND OPEN INTERSECTIONS IN KOLKATA

Wide and open intersections provide no directional assistance to the drivers and encourage random traffic flow resulting in an inefficient traffic system. Intersections are the most vulnerable locations they demand high levels of user guidance. A typical intersection in a main locality of the city is over 60m wide. This allows driver to speed up within the intersection which results in a crash.

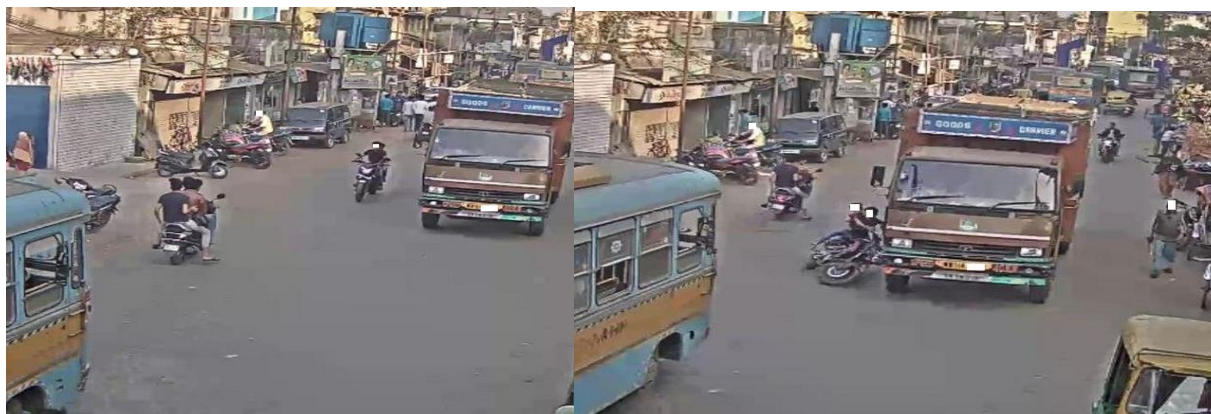
FIGURE 31: EXAMPLE OF AN UNDIVIDED ROAD IN KOLKATA CITY

Crashes involving overtaking, during which a vehicle enters the oncoming traffic lane to overtake the vehicle travelling/parked in-front of it, are common on undivided roads simply because there is no barrier/division in place to prevent them. Such crashes often involve head-on collision, a crash type that frequently results in serious or fatal injuries. An example is shown in Figure 31 where, a motorcycle has encroached into the oncoming lane during the overtaking maneuver exposing itself to the head-on collision with oncoming vehicles.

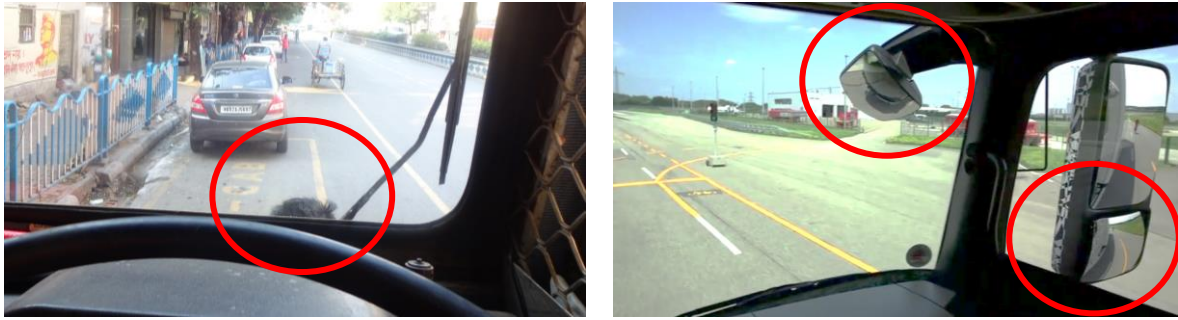
FIGURE 32: ADDITIONAL MIRRORS PROVIDED TO REDUCE DRIVER VISION OBSTRUCTION IN HEAVY VEHICLES

Vision obstruction due to vehicle interior is a vehicle design limitation that restricts the driver’s vision. These vision obstructions create blind spots that usually occur in the front of the driver due to the A-pillar and inadequate coverage of side and rear by the vehicle mirrors.

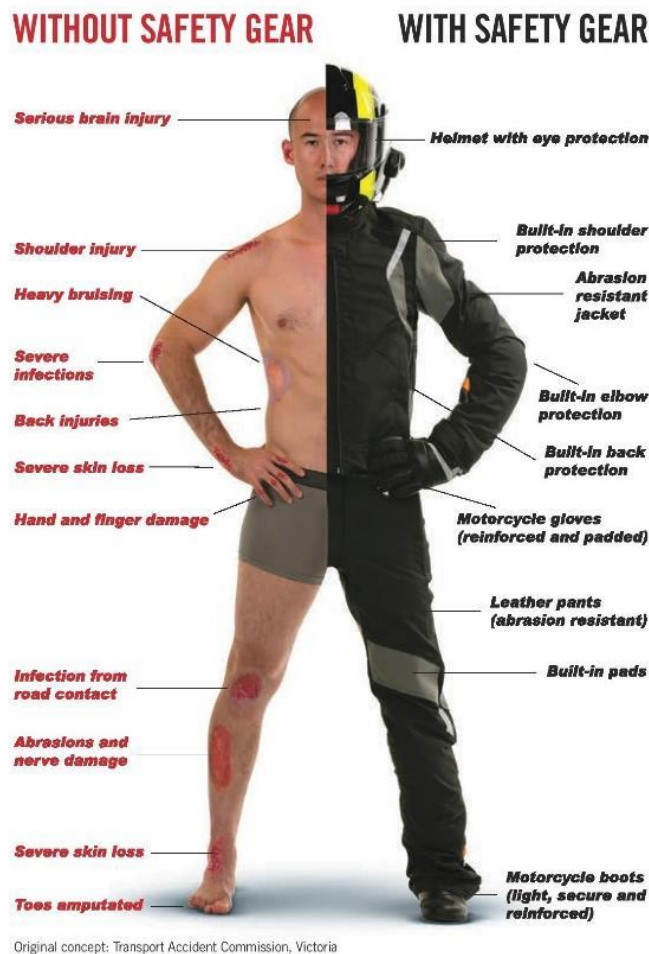
FIGURE 33: INJURY BENEFITS OF GOOD MOTORCYCLE SAFETY GEAR

The explanation for knock down is the same for M2W riders as explained earlier in the Vehicle Factors section for fatal pedestrian crashes. The factor “self-fall” involves a M2W rider losing control over his vehicle due to tire slipping, speeding, etc. and falling down to the ground without any preceding collision with another vehicle. While there are technologies like Anti-lock Braking Systems (ABS) available as an option on some motorcycles, the one counter measure that can help mitigate injuries would be wearing safety equipment. Figure 33 shows an illustrative example showing the injury benefits of using a good motorcycle safety gear.

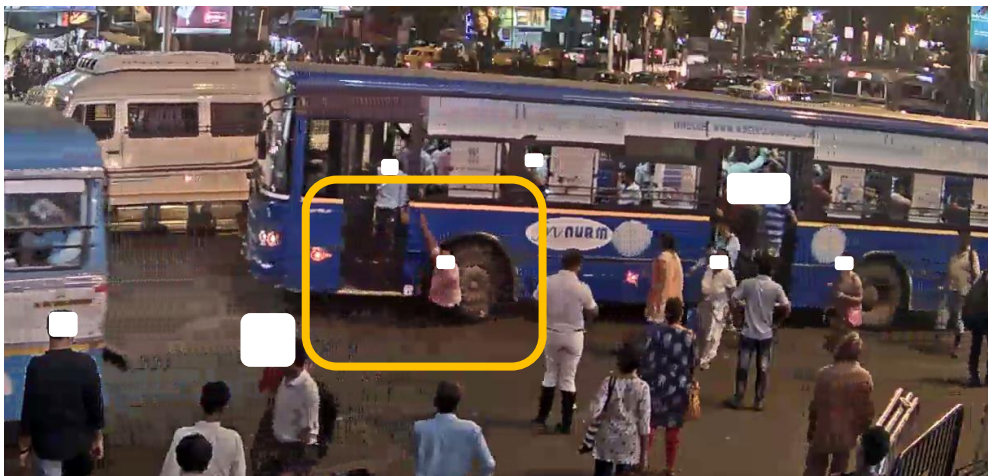
FIGURE 34: RUNOVER OF BUS OCCUPANT  
(PICTURE SOURCE: KOLKATA TRAFFIC POLICE)

In many pedestrian fatality cases, pedestrians get run over by the wheels of impacting vehicle after being knocked down. Such an occurrence is coded as a run over. This stands good for M2W riders/bicyclist as well. Usually vehicles with high ground clearance (buses and trucks) result in a run over of M2W rider/bicyclist or pedestrian. However, in some cases bus occupants fall out of the bus and getting ran over by the wheels as shown in Figure 34.

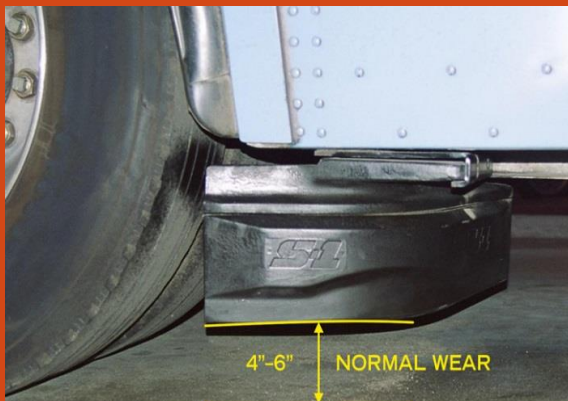
### S1 GARD – RUN OVER PREVENTION DEVICE

S1 Gard is a device installed in public transport buses in many cities in USA to deflect the road users from coming under the wheels of a bus. These devices are claimed to be highly effective for public transportation, to save bus occupants, pedestrians, bicyclists, M2W riders from coming under the wheels. The device consists of a curved polyurethane guard, mounted in front of the right rear wheels of transit buses, designed to deflect a person out of the path of the wheels in order to prevent injury or death.

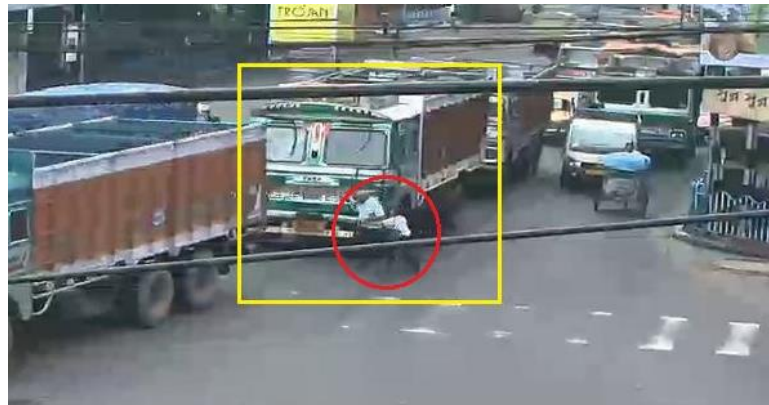
FIGURE 35: PEDESTRIAN DANGEROUS BEHAVIOUR  
(PICTURE SOURCE: KOLKATA TRAFFIC POLICE)

Education campaign focusing on pedestrian behaviour on road will help in mitigating crashes related to this factor. In pedestrian crossing accidents, pedestrians attempts to cross in front of slow moving heavy vehicles. Due to vehicle interiors, the drivers vision are obstructed and couldn't able to see the pedestrians and act accordingly. Thus, impacting the pedestrian and further running over them causing fatal injuries. This awareness needs to be raised among various categories of pedestrians such as old aged people, students going to school/college, parents taking their children to schools, women going for shopping and other pedestrians. Figure

35 shows an adult holding the hands of a child, crossing the road in front of a heavy vehicle. Due to vehicle interiors, driver's vision is obstructed.

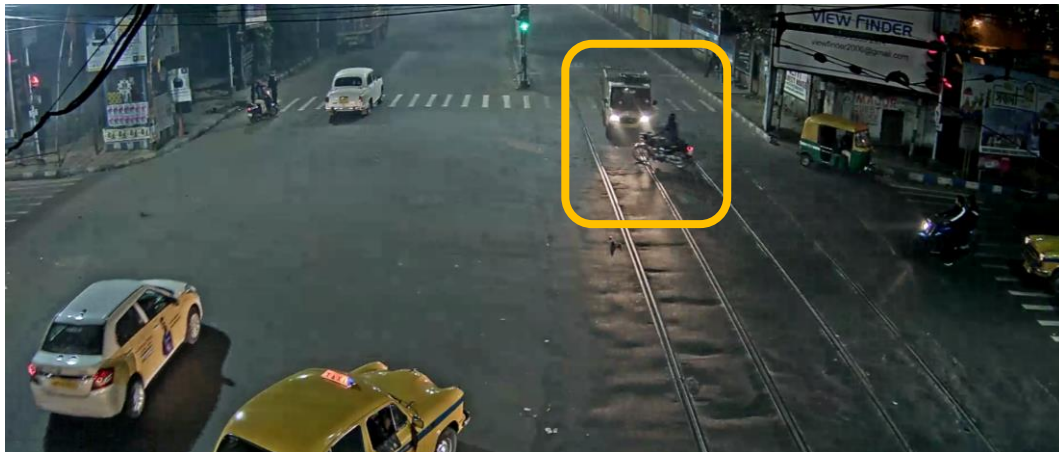
FIGURE 37: VIOLATION OF TRAFFIC SIGNALS  
(PICTURE SOURCE: KOLKATA TRAFFIC POLICE)

Figure 37 shows a motorcycle rider violating the traffic signal exposing to the moving traffic on the other arms of the intersection. Stricter enforcement on violation of signals will help in reducing these crashes.

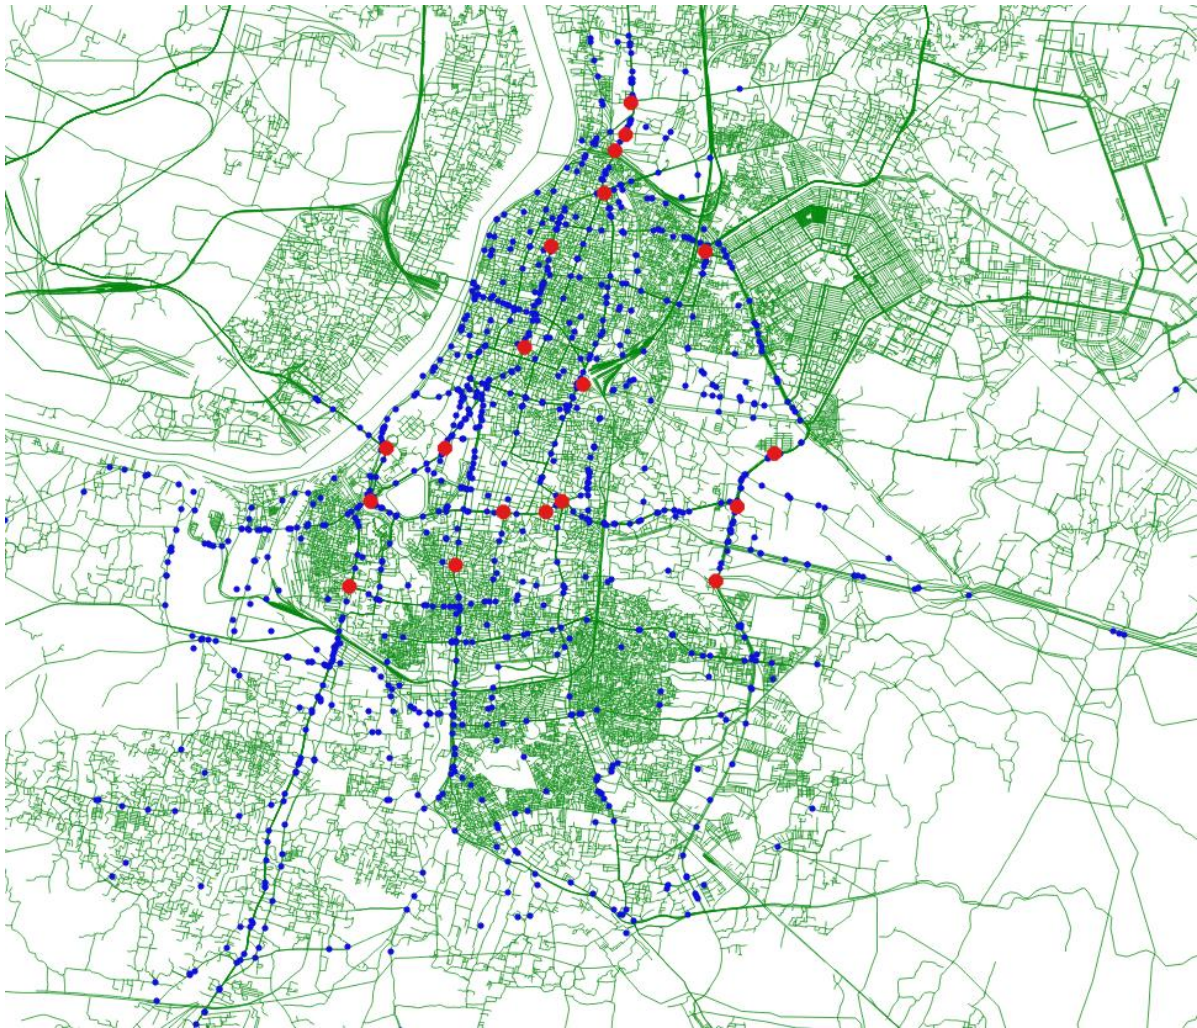
**FIGURE 41: FATAL CRASH SPOTS IN BLUE; BLACK SPOTS IN RED. (OUTPUT FROM QGIS SOFTWARE)**  
Details of police station in charge of the crash spot and the area names with landmark is shown for all the 19 identified black spots in the Figure 42.
