# iRAP Baseline Data Collection in India

Final Report – Karnataka Phase

**JP Research India Pvt. Ltd.**

30 March 2012

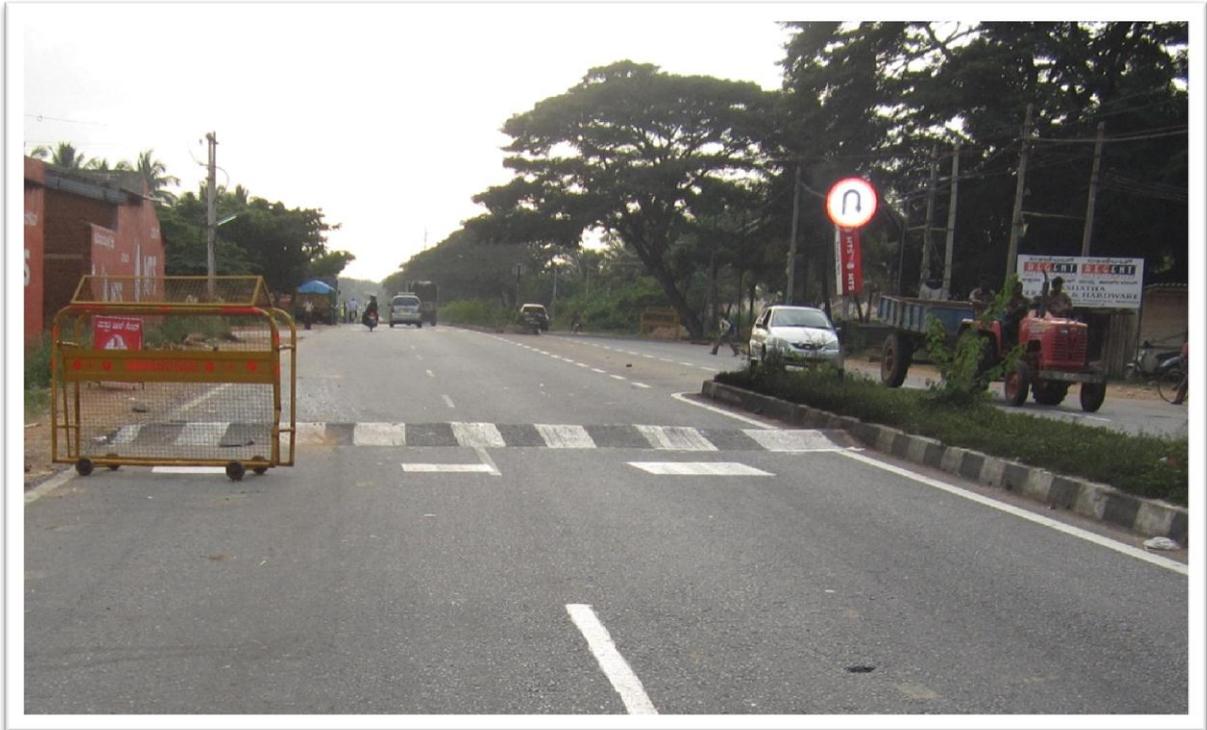
*Shown above is a picture of a section of the State Highway 17 (SH17) between Maddur and Srirangapattana. A typical gap-in-median is shown having a speed breaker (which looks like a pedestrian crossing). In addition, the picture also shows the presence of farm tractors on the road. A barricade being used to slow down traffic before the gap-in-median is also seen on the left. It tries to reduce speeds of vehicles by blocking the left lane.*

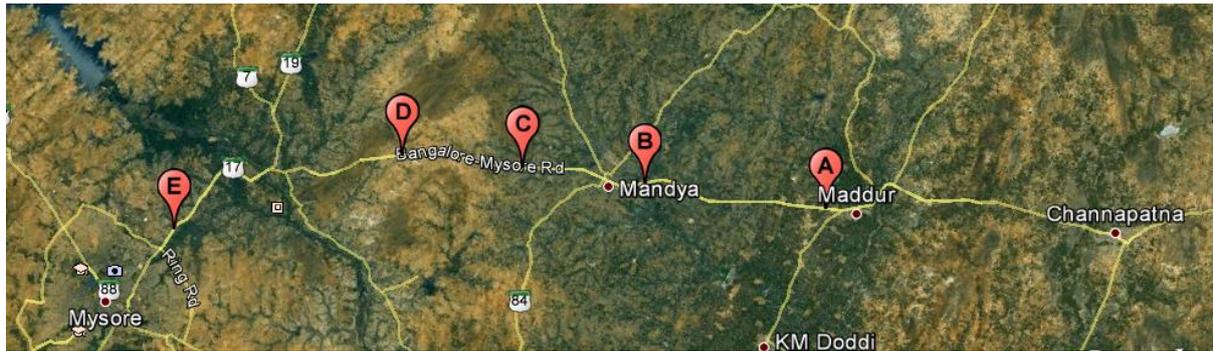
Figure 1: Screen shot from Google Earth, showing the study sites (Sites A, B, C, D and E)

The stretch was carefully studied to determine places where significant traffic was being added to the highway or being subtracted from it. These places usually include major towns or villages that draw frequent on/off traffic, either as destinations in themselves or as connections to some other place. Spots around these locations offer a good idea of the traffic volume for the whole stretch selected. It was found that most of the traffic is added or subtracted around towns and cities such as Maddur, Mandya and Srirangapattana. The study sites on SH17 have been identified by the Global Positioning System (GPS) coordinates and area type provided in Table 1, and they are shown graphically in Figures 1 and 2.

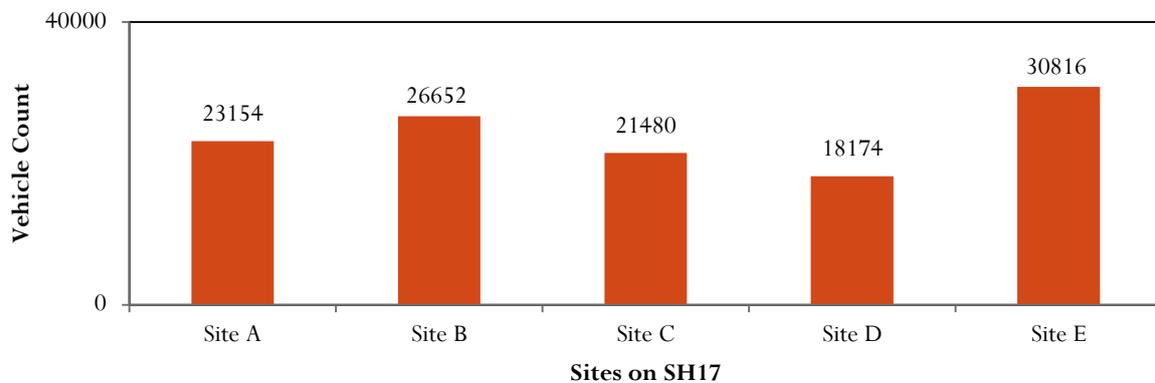
Figure 3: Traffic volume count at each site on SH17 estimated for 24 hours

This one hour sample was then extrapolated to the specific 6 hours' time duration. The end results were then added to get an estimation of the number of vehicles passing through a given site in 24 hours. Based on the above calculation, the new total vehicle count obtained for SH17 is **120,276** and the total vehicle count at each site is as show below in Figure 3.

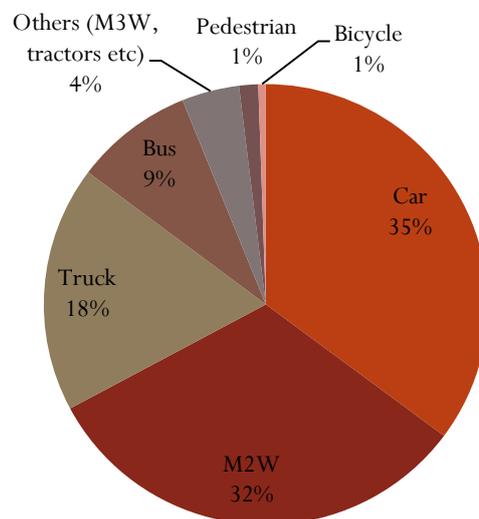
Figure 4: Percentage composition of road users counted on SH17  
(Sample Size: 120,276 vehicles counted at all sites during the four time durations)

Figure 4 indicates that cars (35%) constituted the highest road user type counted on the SH17. This was followed by motorized two wheelers (32%) and trucks (18%). Buses, other motor vehicles, pedestrians, bicyclists and non-motorized vehicles together accounted for 15% of the total traffic volume.

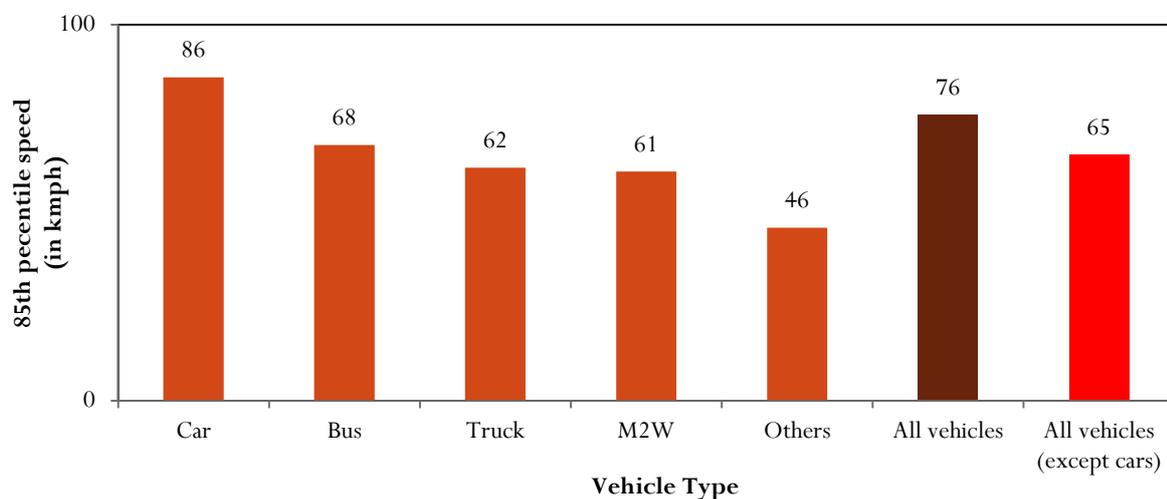
Figure 6: Average “85<sup>th</sup> Percentile Speed” of each road user type in all study sites on SH17

It can be seen from Figure 6 that cars were found to be travelling the fastest with 85<sup>th</sup> percentile speed of 86 kmph. Cars were followed by buses and trucks at 68 kmph and 62 kmph respectively. The 85<sup>th</sup> percentile speed of all vehicles was calculated as 76 kmph. But when cars were excluded in the calculation, 85<sup>th</sup> percentile speed of all vehicles was 65 kmph. Speed limit posts are mostly absent on these highways and the available posted speed limits of 30 kmph were far lesser than the actual speed measured.

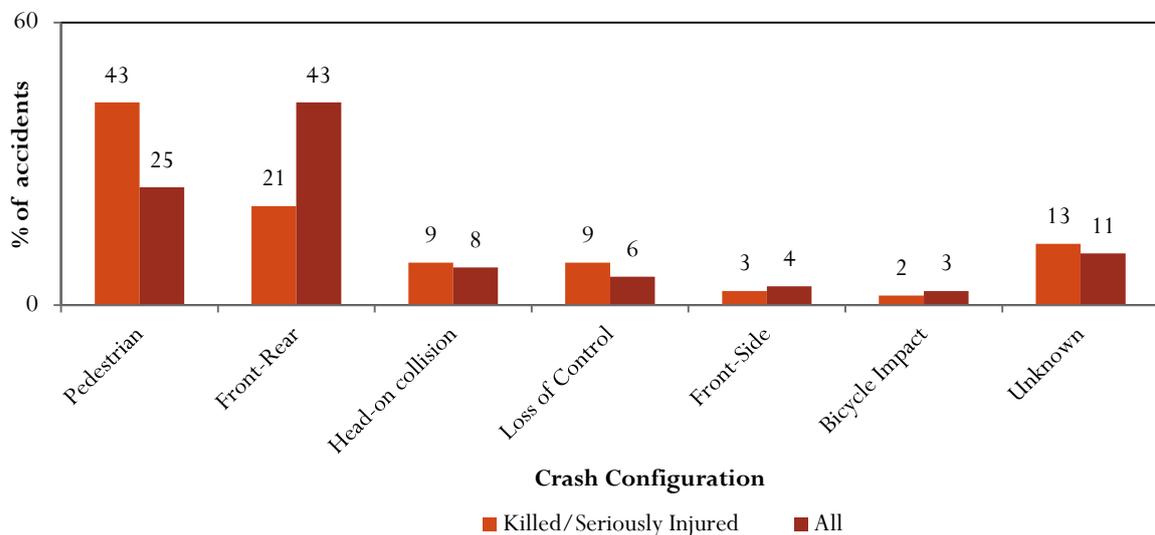
Figure 10: Percentage of accidents by crash configuration and injury severity

The 1164 accidents were distributed as per the crash configurations and results were plotted as shown below in Figure 10. *The definitions for the various types of crash configurations are provided in Appendix C.*

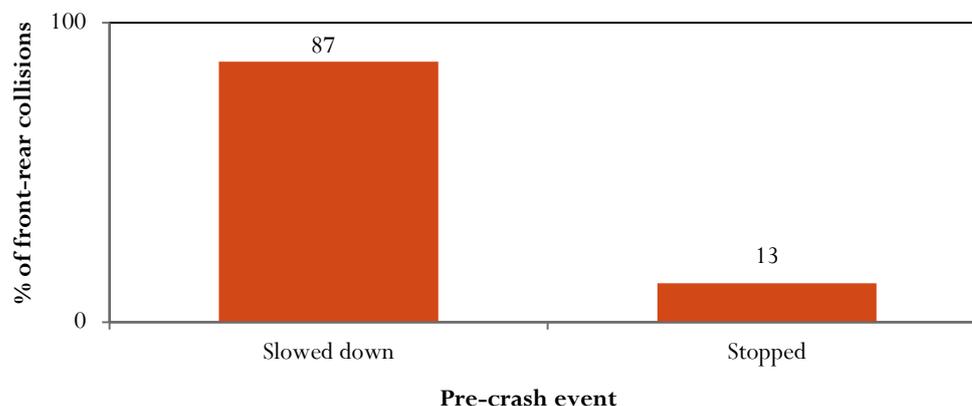
Figure 21: Pre-crash event for front-rear collisions

The pre-crash event for each of the front-rear collisions was identified and the results are as shown in Figure 21.

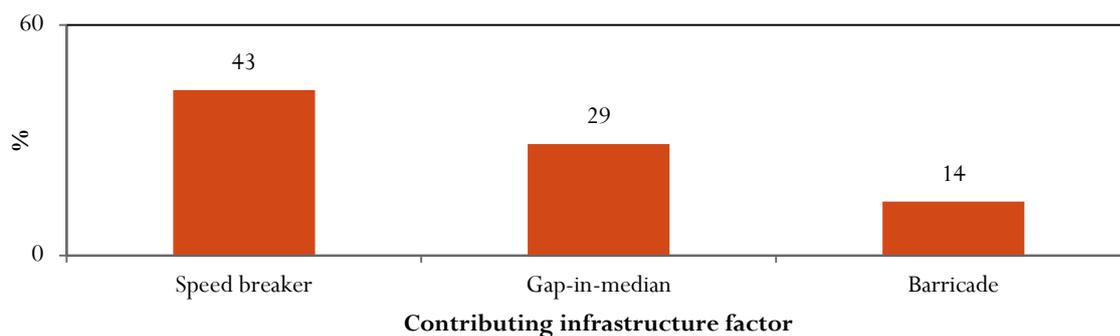
Figure 22: Contributing infrastructure factors leading to pre-crash event “slowed down” and causing front-rear collisions

Since slowing down of vehicles caused 87% of the front-rear collisions, the influencing infrastructure factors for these conditions were examined, and the results are as shown in Figure 22.

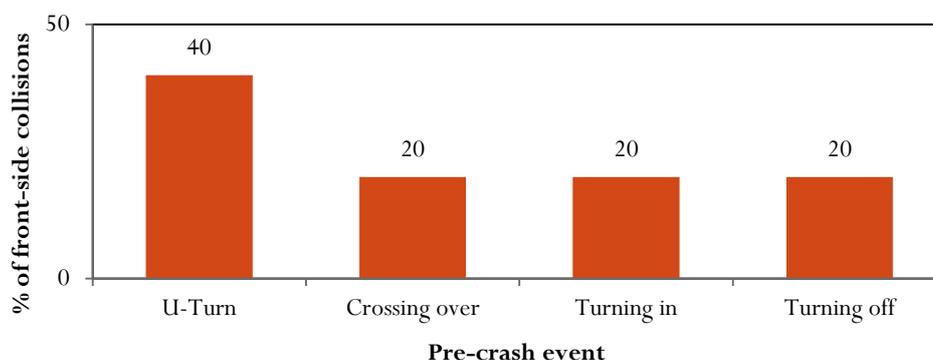
Figure 23: Pre-crash event for front-side collisions

The pre-crash event for each of the front-side collisions was identified and the results are as shown in Figure 23. As can be seen, in all the cases, once of the vehicles was turning off/in the highway, taking a U-turn or crossing over an intersection.

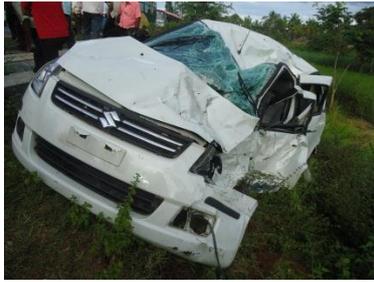
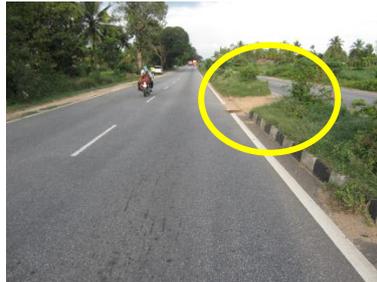
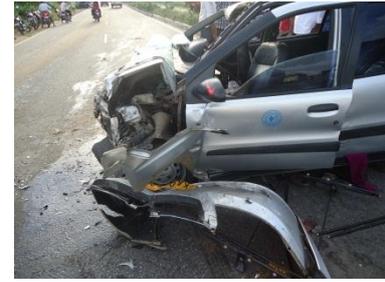
Figure 25: Scene diagram & images for the head-on collision examined on the SH17 showing how a gap-in-median influenced this accident.

This accident has been discussed to show how head-on collisions can take place on divided 4-lane roads. It is well known that head-on collisions can occur when vehicles are travelling in the wrong direction on a divided highway, but in this case a car lost control, crossed the median and then impacted another car coming in the opposite direction.

The car that lost control

The gap-in-median

The car travelling in the opposite lane

There were many gaps in medians which were found to be made just by breaking the median, and were without any proper finishing as can be seen in Figure 25. They even lack information signs about a U-turn present in such location. Police informed that it is the general public which used to cut open the median which could be used as a shortcut to access cross roads nearby.

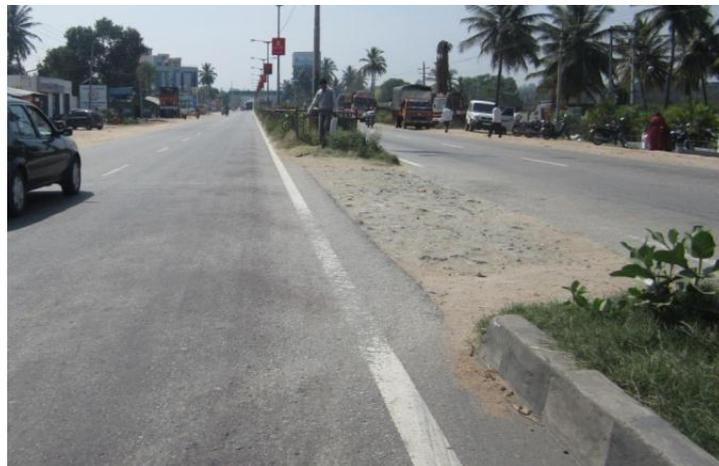
Figure 26: Crude gap-in-median. Roadway also lacks information signs

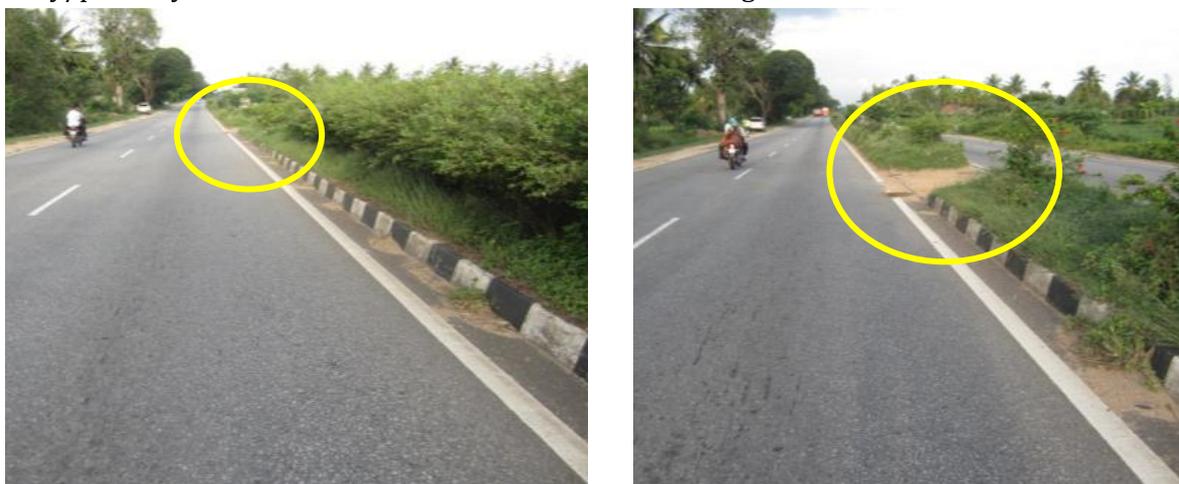
Plants on the median are usually grown to cut off headlight glares from vehicle travelling in opposite direction. But such plants were also found near the gaps in medians which totally/partially obstructed the vision of road users accessing the U-turns.

Figure 27: Driver's ability to see upcoming U-turn is obstructed by plants (left); the same U-turn is visible suddenly when the driver comes closer. (right)

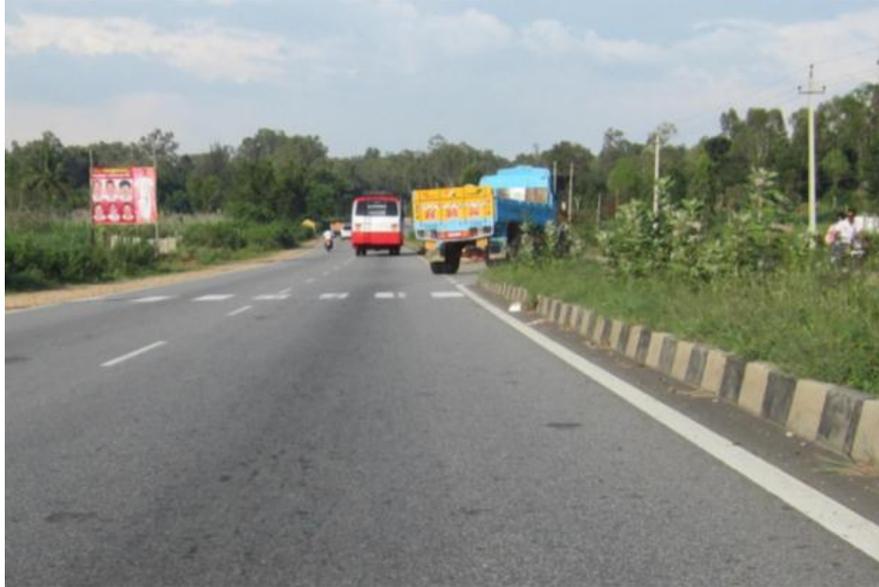
Figure 28: Absence of deceleration lanes near U-turns

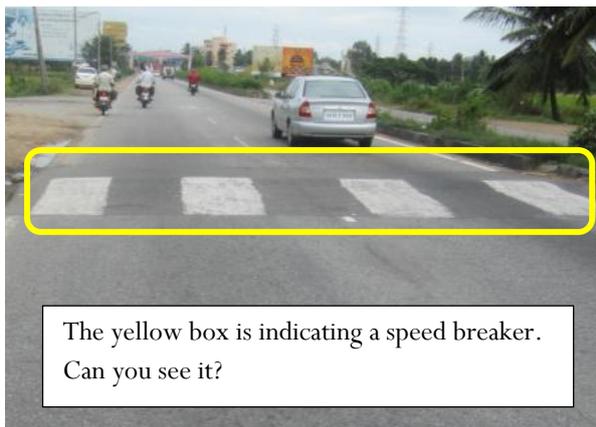
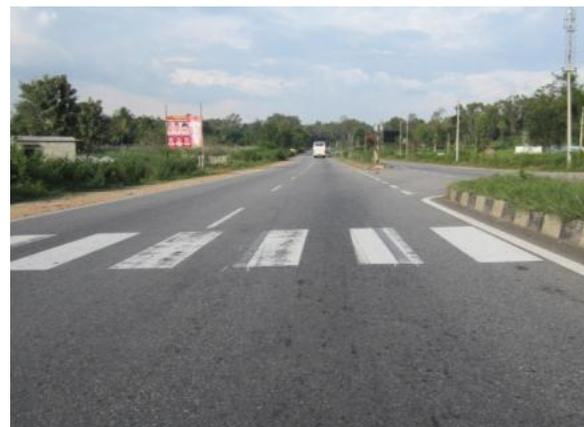
The speed breakers found on SH17 were painted with white vertical stripes (parallel to the vehicle direction). This pattern created an optical illusion such that the elevation of the hump disappeared and it looks like a pedestrian crossing (Figure 29). Also the conspicuity of these speed breakers was poor during the night (Figure 30). Due to these problems, riders and drivers often don't realize there is a speed breaker until they are upon it, which can cause loss of control of their vehicles, as was seen in this study.

Figure 29: Longitudinal pattern of white lines on speed breakers make it look like a pedestrian crossing (left); Actual pedestrian crossing (right)

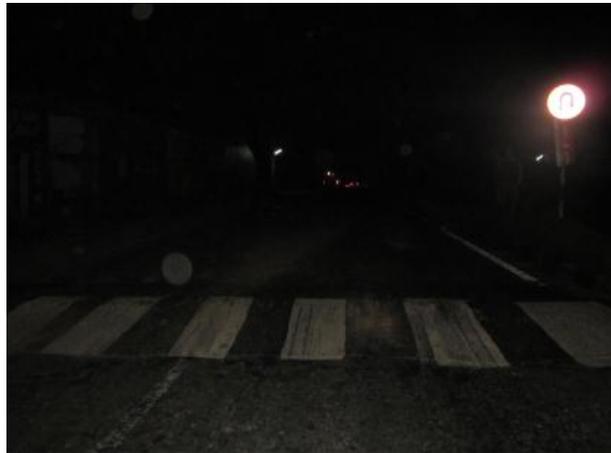
Figure 30: Speed breakers lacked conspicuity at night

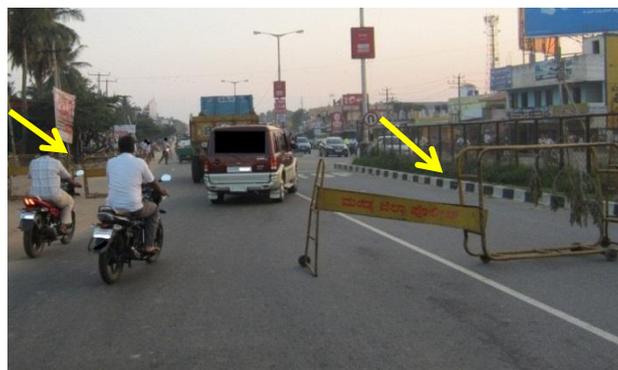
Barricades were placed on roadway near busy areas in order to cut speeds of passing vehicles. But these barricades were placed in wrong locations (very close to a U-turn, etc.) which confused the path of vehicles travelling through them. Also the barricades were seen to be very old and in extremely bad condition (Figure 30). They also lacked reflectors or warning signs on them making their presence less visible on the road.

Figure 31: Barricades on roadway were found in very bad condition and lacked conspicuity

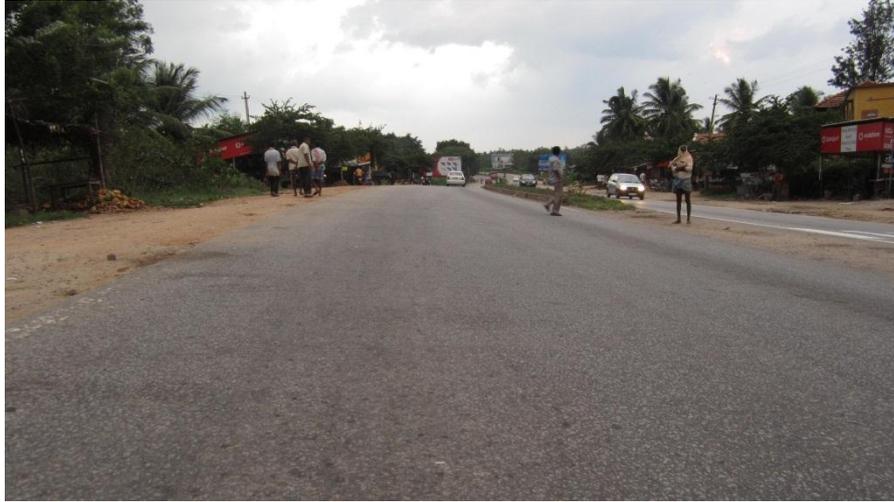
Lack of proper pedestrian facilities on the study stretch of SH17 forces pedestrians to walk on the carriageway, and that action likely makes them more prone to being hit by vehicle traffic. At least one pedestrian impact seen during the study was determined to be influenced by this factor. Absence of pedestrian crossings and improper maintenance of those that do exist not only put pedestrians in harm's way, but may indirectly lead to other accidents as vehicles attempt to avoid collisions with pedestrians and bicyclists.

Figure 32: Poor pedestrian infrastructure on SH17.

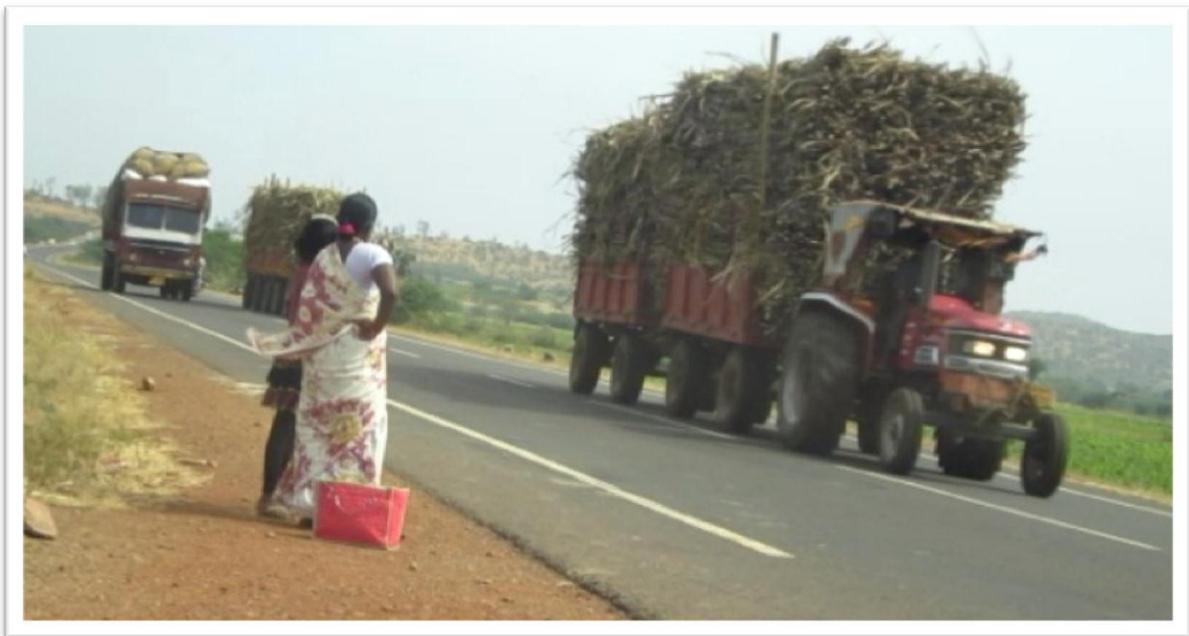
*Shown above is a picture of a section of the State Highway 20 (SH20) between Belgaum and Bagalkot. Tractors carrying sugarcane and farm goods (note the double trailers) are a common sight. In addition, the picture also shows an overloaded truck trying to overtake a tractor. Also seen are a mother and daughter waiting on the road side for a lift. Also observed were the narrow paved shoulders of width 1.5m.*

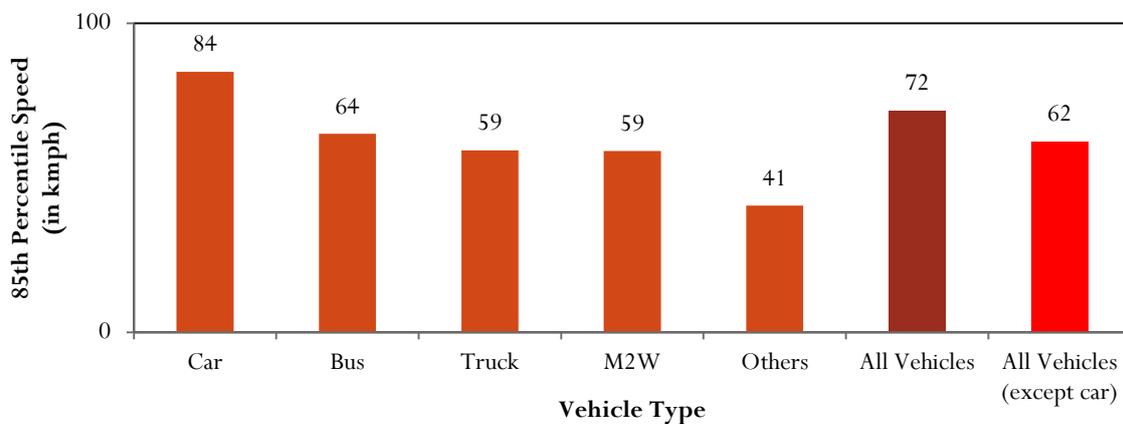
Figure 6: Average “85<sup>th</sup> Percentile Speed” of each road user type in study sites (A, B, C and D) on SH20 in Belgaum district

Figure 6 clearly denotes that in study sites of Belgaum district cars travel the fastest, with an average 85<sup>th</sup> percentile speed of 84 kmph. This is then followed by buses, trucks and motorized two wheelers with average 85<sup>th</sup> percentile speeds of 64 kmph, 59 kmph, and 59 kmph respectively. The 85<sup>th</sup> percentile speed for all the vehicles was found to be 72 kmph, and it was 62 kmph when cars were excluded from the calculation.

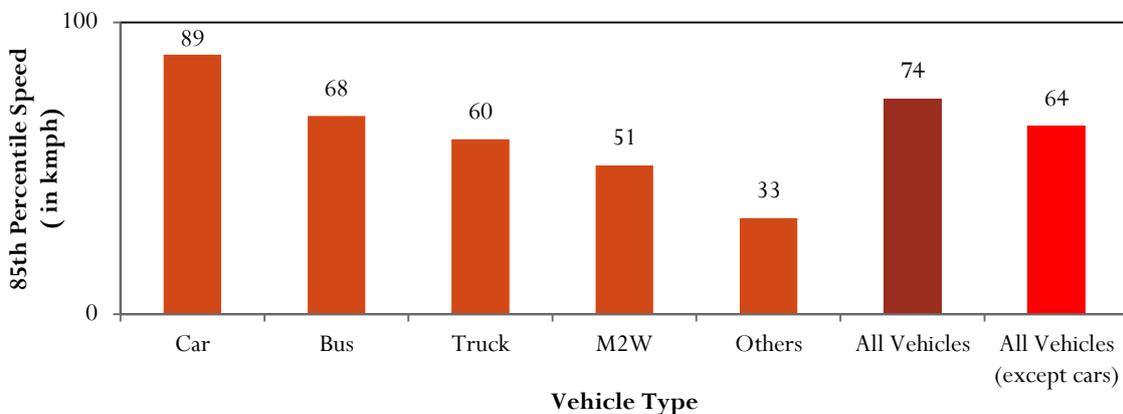
Figure 7: Average “85<sup>th</sup> Percentile Speed” of each road user type in study sites (E, F, and G) on SH20 in Bagalkot district

Figure 7 clearly denotes that in study sites of Bagalkot district cars travel the fastest, with an 85<sup>th</sup> percentile speed of 89 kmph. This is then followed by buses, trucks and motorized two wheelers with 85<sup>th</sup> percentile speeds of 68 kmph, 60 kmph, and 51 kmph respectively. The 85<sup>th</sup> percentile speed for all the vehicles was found to be 74 kmph, and it was 64 kmph when cars were excluded from the calculation.

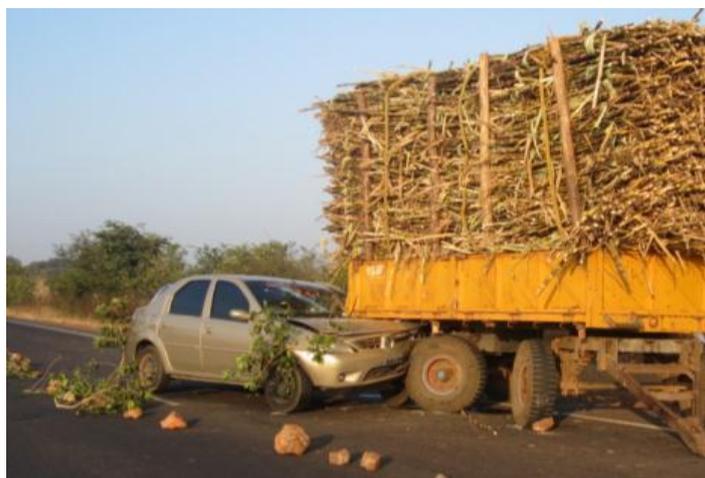
For the front-rear collisions involving a “parked vehicle in front” as pre-crash event, it was noted that all these vehicles were standing on the road side shoulder. As the road side shoulder is narrow (1.5 m width), part of the vehicles is on the road way. Hence, narrow paved shoulders were identified as the contributing infrastructure factors for these cases which account for 50% of the front-rear collisions.

Figure 13: A car rear ended an unattended trailer parked on the shoulder

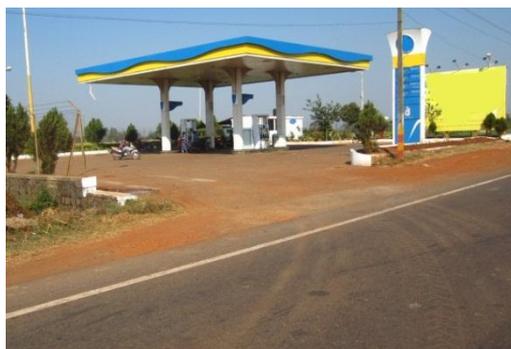
In 3 of the 4 cases, pre-crash event was overtaking while in one case a head-on collision was caused due to a motorcyclist exiting a gas station and a minibus travelling in the opposite direction of the motorcyclist.

Figure 14: Entry/Exit to a gas station on SH20

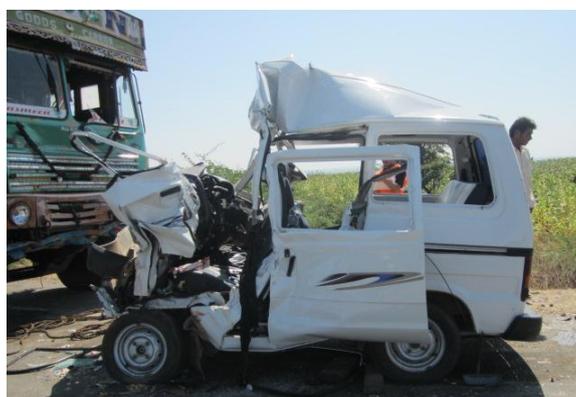
Figure 15: Van and the truck inspected on SH20

These types of accidents occur when a vehicle moves into the oncoming lane on an undivided road for overtaking. Hence undivided road influences these kinds of accidents a lot. In one of the cases, an overtaking Maruti Omni (van) collided head-on with a truck travelling in opposite direction. This accident resulted in 5 fatalities in the van.

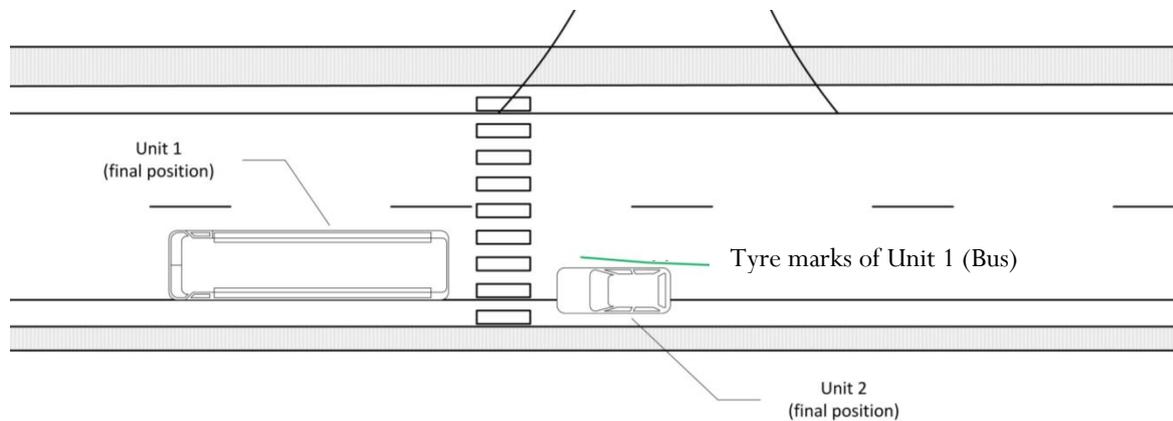
Figure 16: Scene diagram showing the sideswipe collision between the car and the bus

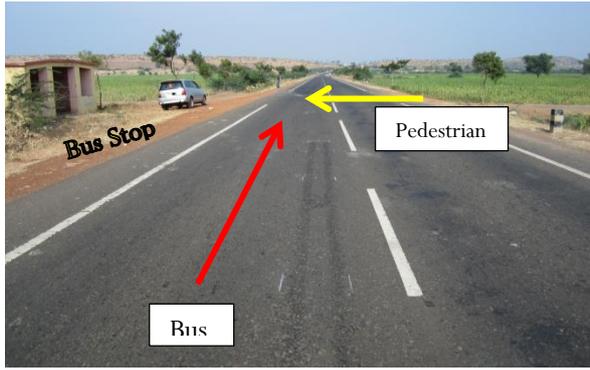
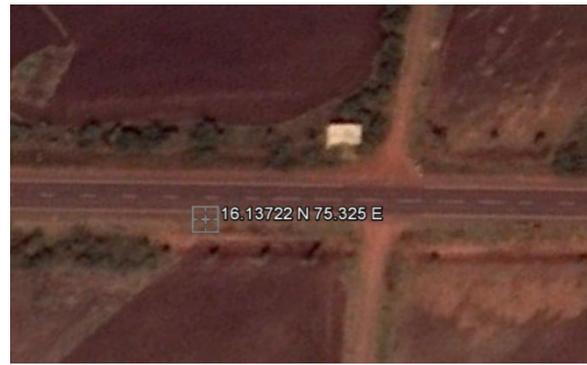
Figure 17: Scene of pedestrian accident with a bus. The location is a junction and also has a bus stop. But there are no warning signs or pedestrian infrastructure.

It is clear that driver vision obstruction (caused due to the pedestrian crossing the road from behind the bus) was the reason that the pedestrian accident could not be avoided, but from the infrastructure point of view it is also visible from photos that adequate pedestrian infrastructure has not been provided to inform drivers in advance to drive carefully through this junction.

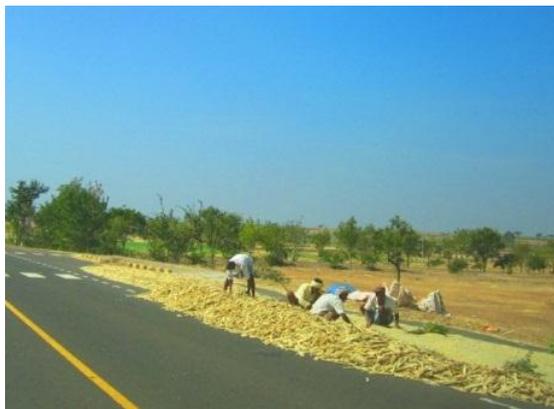
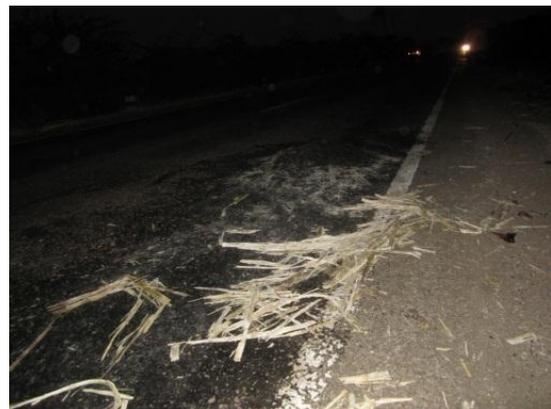
There are farms on both sides all along the stretch. The agricultural produce from these farms is often seen to be laid out on the roads for drying or loading onto trailers towed by farm tractors. This produce on the road creates conditions for vehicles to skid and lose control, thus, causing injury not only to the road users but also to the farmers.

Figure 18: Agricultural produce on the road causes vehicles to skid

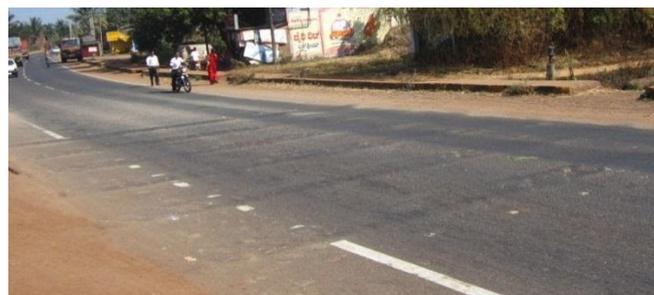
Figure 19: Rumbler strips as seen on SH20

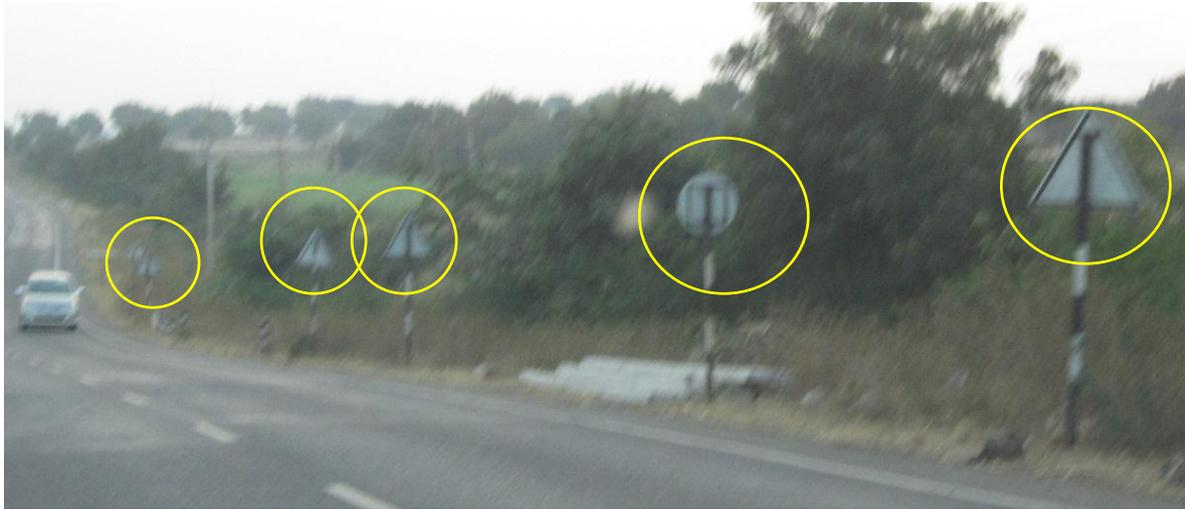
Figure 20: A series of road signage on SH20 near Chandargi

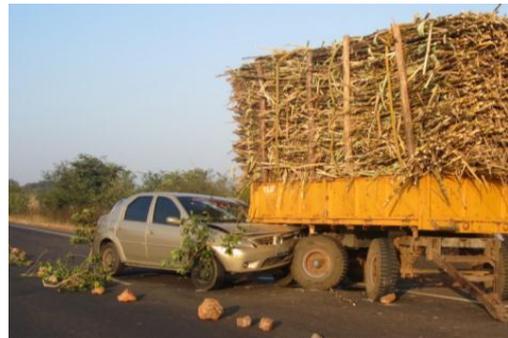
### Front-Rear Collision

This type of collision occurs between two vehicles, where one vehicle (leading) is travelling/stopped ahead of the other vehicle (following), both travelling in the same direction. Usually such collisions occur due to the slowing down of the leading vehicle, or with a stationary (parked/stopped) vehicle, as shown in figure. Note that this example also shows a trailer under-ride, which can be particularly dangerous to occupants of the following vehicle since that vehicle may have virtually no protective/bumper contact with the leading vehicle until its bumper reaches that vehicle's tires (or until the windshield/cab of the passenger compartment contacts the rear of the truck/trailer).

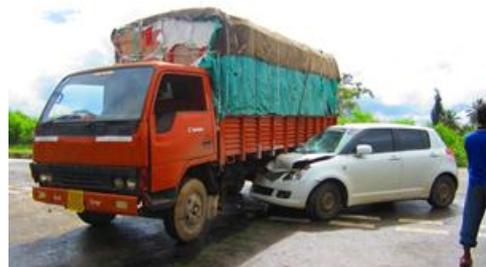
### Front-Side Collision

This type of collision occurs between two vehicles, where the front plane of one vehicle's contacts the side plane of another vehicle during collision. Most commonly, this sort of collision takes place in intersections and during U-turns.

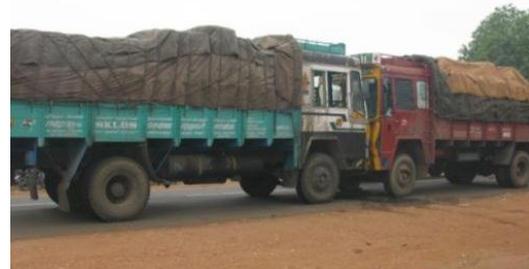
### Head-On Collision

When two vehicles approaching each other in opposite directions collide with each other, such a collision is called a head-on collision. It is most common on undivided roads, when one vehicle is trying to overtake and is in the oncoming lane. Speed and relative size of the colliding vehicles can greatly affect how serious this type of collision is in terms of occupant injury and vehicle damage. The

head-on collision shown in figure, for example, reveals very little crumple; the same scenario with a compact car in the place of one of the trucks would likely show a very different outcome.

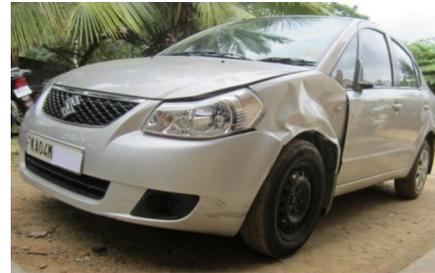
### **Sideswipe**

Side-swipe is when two vehicles, travelling in the same direction or in opposite direction to each other, collide in such a way that their side planes (as shown in figure) just rub each other with a very little overlap between the two.

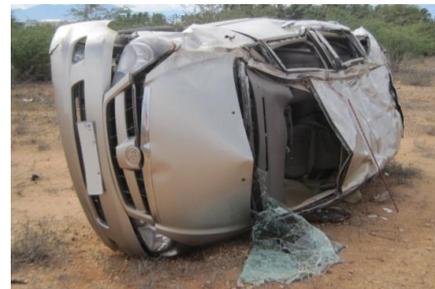
### **Rollover or Loss of Control**

Rollover describes the overturning of a vehicle along its longitudinal or lateral axis. The usual case is when a vehicle loses control, goes off-road, and rolls. However, a rollover can also take place on-road. In case of two wheelers losing control and falling down, such an event would only be called a “Loss of Control”. As shown in figure, a rollover means that multiple sides of the vehicle will come into contact with ground or other objects, presenting multiple opportunities for occupant contact with the vehicle’s interior and for the vehicle to come into contact with objects that could lead to intrusion into the passenger compartment. Rollovers can also be initiated by any another type of collision (a sideswipe, for example), but often they are single-vehicle crashes.
