CREATION OF AN IN-DEPTH ROAD TRAFFIC CRASH DATABASE FOR INDIA: THE COIMBATORE RURAL DISTRICT CASE STUDY

JP Research, Inc.

Paper Number 11-0100

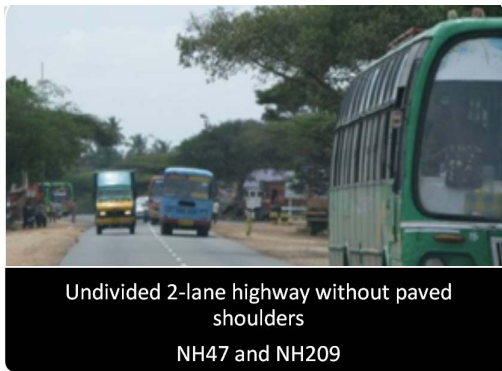
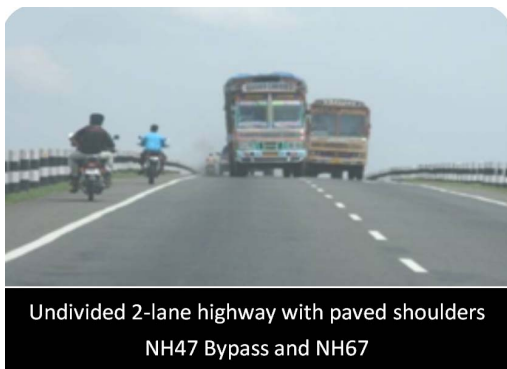
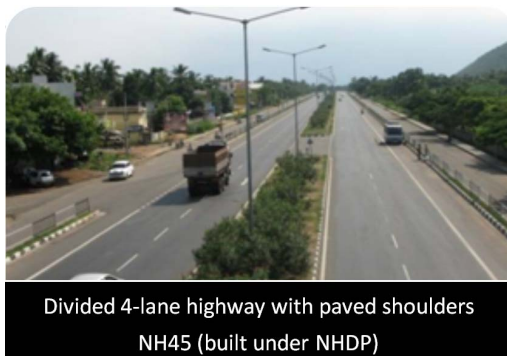
Figure 1A, 1B and 1C: Types of Indian National Highways Studied.

Finally, infrastructure variables were collected on scene to be entered into the database. These included the configuration of the road and roadside, traffic control information, road and weather conditions and other pertinent information. Figures 1A, 1B and 1C show the types of highways investigated in the studies.

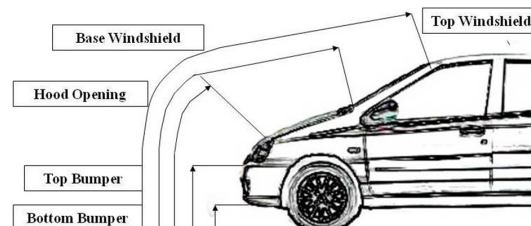
Figure 2: Vehicle Wrap Measurements Collected for Pedestrian Crashes.

Data forms addressing different types of road users were developed. For pedestrians, data on height/ weight, as well as their knee, hip and shoulder height measurements were used to match up vehicle damage, although this data was not always available. In a methodology similar to the National Highway Traffic Safety Administration's (NHTSA) Pedestrian Crash Data Study (PCDS), an X and Y axis was created on the vehicle's hood and windshield. The X axis is the farthest forward point of the base of the windshield, and is extended left and right. The Y axis is the center of the vehicle. Then, any pedestrian contact points (dents, blood, scuffs, etc) were measured along this axis to establish the specific point on the vehicle where the contact occurred. In addition, 'wrap' measurements were taken for any vehicle that struck a pedestrian, as shown in Figure 2. Wrap measurements are measurements taken from the ground that wrap around the vehicle. For example, the wrap measurement for the base of a windshield would start on the ground and wrap up the vehicle's bumper, across the entire length of the hood and then end at the base of the windshield. These measurements were useful in establishing how the pedestrian interacted with the vehicle during a crash.

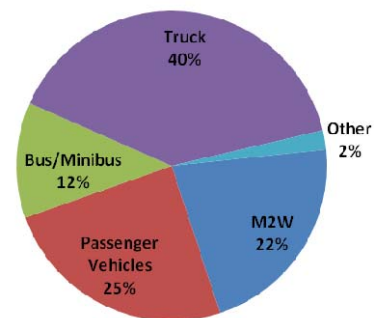
Figure 3: Distribution of Crash Vehicles by Vehicle Type (2008-2010).

About 40% of vehicles involved in crashes were heavy trucks, followed by passenger vehicles², which accounted for 25% and then motorized two wheelers (M2Ws), accounting for 22% of vehicles.

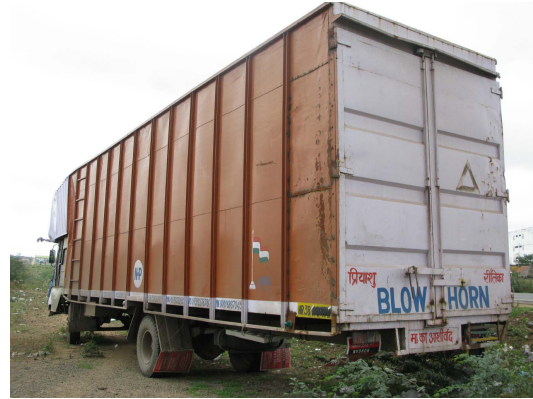
Figure 5: Heavy Truck Without Functioning Brake Lights, Rear Reflectors or Underride Protection During the 2010 Coimbatore Study

Given the high incidence of front-rear collisions and heavy truck involvement, underrun protection for heavy trucks is essential for road safety. Underride impacts usually results in the passenger vehicle taking the impact at the level of the hood, radiator or A-pillars and not the bumper, where the vehicle is designed to absorb an impact. The importance of underrun protection is compounded by the fact that many heavy trucks in India are not equipped with reflectors or brake lights, making them extremely difficult for drivers to see at night. This lack of visibility makes night time rear end collisions with heavy trucks more likely. Figure 5 illustrates an example of a heavy truck examined during the Coimbatore study that was not equipped with underrun protection or rear reflectors.

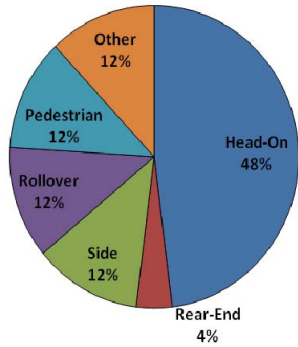
Figure 6: All Light Vehicle Crashes by Crash Type

As seen in Figure 6, 48% of light vehicle crashes were head-on collisions. On undivided highways, there were many opportunities to encroach into oncoming traffic unintentionally or during a passing maneuver.

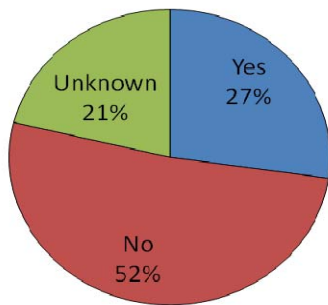
Figure 7: Seatbelt Usage for Occupants in Passenger Vehicles

Safety system use was low for all vehicles involved in the study regardless of the type of system available. The studied passenger vehicle population had a belt use of 27%, as seen in Figure 7.

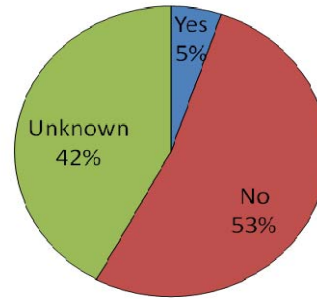
Figure 8: Helmet Usage for Riders on Motorized Two Wheelers

Helmet use was also found to be very low among M2W drivers and passengers in the study. Despite helmet use being mandatory by law in India, the actual rate was seen to be extremely low in crashes researched, as is shown in Figure 8. Many riders were observed to have suffered serious head injuries due to lack of helmet use.

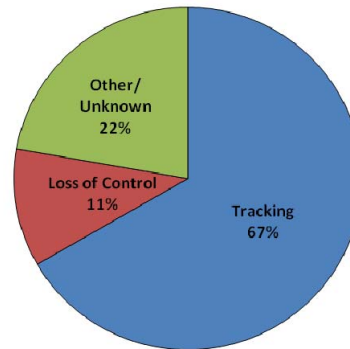
Figure 9: Distribution of Pre-Impact Stability

The pre-impact stability of vehicles was assessed by examining the accident scene, vehicle skid marks, direction of traffic, terrain and other factors prior to crash. 11% of vehicles involved driver losing control prior to impact, as shown in Figure 9. Loss of control was defined as when a vehicle was not tracking straight (following its intended path), but instead was skidding or rotating either longitudinally or laterally prior to impact. For example, if the vehicle was rotating clockwise or counterclockwise and was not following its intended path, this was considered a loss of control for the vehicle's pre-impact stability.

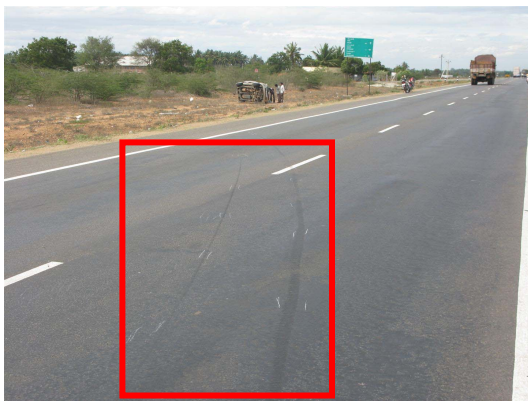
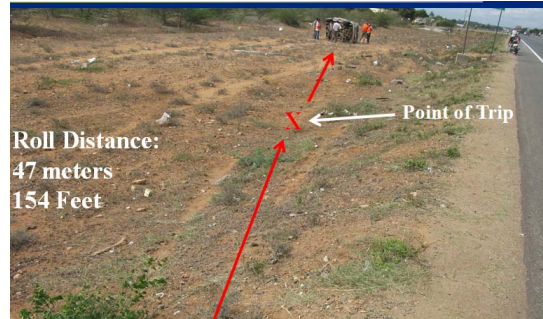
Case 31	Weather : No adverse atmospheric conditions
NH 47 Bypass	Date : 16/08/2010
All dimensions are in metres	Time : 2130

Figure 10A, 10B and 10C: Example of a Rollover Crash Caused by the Loss of Control of the Vehicle in the Roadway

The installation of electronic stability control (ESC) could be a useful countermeasure to maintain vehicle control. For example, one of the cases investigated (Figure 10A) shows the skid marks left on the roadway by a vehicle that lost control and departed the roadway, and then rolled over. Figure 10B shows the scene diagram for this crash and illustrates the sequence of events leading up to the crash that were coded by the investigators. While rollovers were relatively infrequent in the studied population, unique data elements for rollover

crashes were coded. These included: pre-rollover maneuvers (whether the vehicle departed road, struck an object, returned to road, etc); rollover initiation type (a trip-over, climb-over, impact with object, etc); the number of quarter turns and the rollover distance. In this case, the vehicle passing another vehicle in the oncoming traffic lane attempted to steer back into its lane. The vehicle lost control and began to rotate and departed the roadway. The vehicle's pre-rollover maneuver was departing the roadway and the rollover event was a trip-over. The vehicle then rolled seven quarter turns, over a distance of 47 meters (154 feet), as shown in Figure 10C, which indicated that this was a severe crash.

Had this vehicle been equipped with ESC, the driver could have maintained control and remained on the roadway, avoiding this crash altogether.

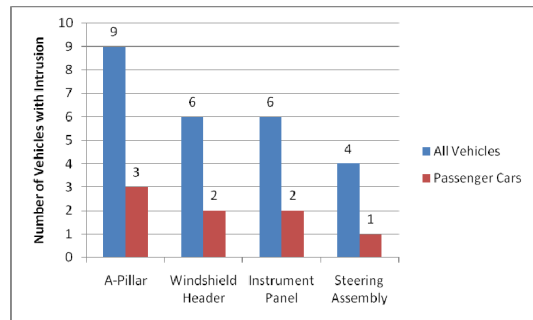
Figure 11: Passenger Compartment Intrusion by Intruding Component

In addition to accident factors, the study team looked at vehicle factors related to crashes. While one vehicle can have multiple intrusions to a single component (such as two A-pillar intrusions), each component was only counted once per vehicle to examine and identify intrusion patterns. Intrusion per vehicle by intruding component, as seen in Figure 11, shows that the most frequently intruding component was A-pillar, followed by windshield header and the instrument panel.

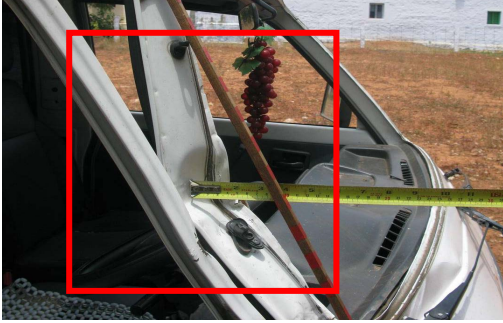
Figure 12: Example of A-Pillar Intrusion

The actual amount of intrusion is determined by comparing the measurement at a particular location in the damaged vehicle with that of an exemplar vehicle. An example of an A-pillar intrusion sustained during a crash is illustrated in Figure 12. This intrusion was sustained when the vehicle was involved in a frontal impact with another vehicle, resulting in induced damage and intrusion to the A-pillar.

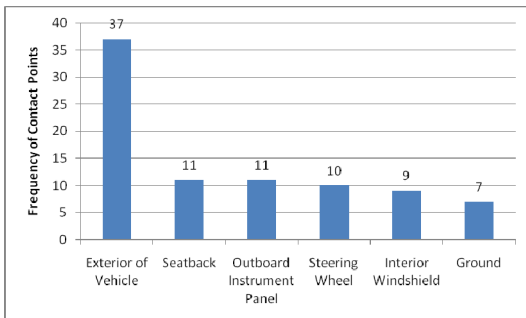
Figure 13: Frequency of Occupant/Pedestrian Contact Points

In addition to vehicle factors, occupant factors including contact points (interior and exterior) and restraint use were examined. Figure 13 presents occupant contact points. The high number of contacts to a vehicle's frontal components, such as the instrument panel, steering wheel/assembly and the windshield suggest that airbags or collapsible steering columns could be effective safety measures to mitigate occupant injury. Needless to say, an increase in restraint system use would significantly reduce injuries in these types of crashes.

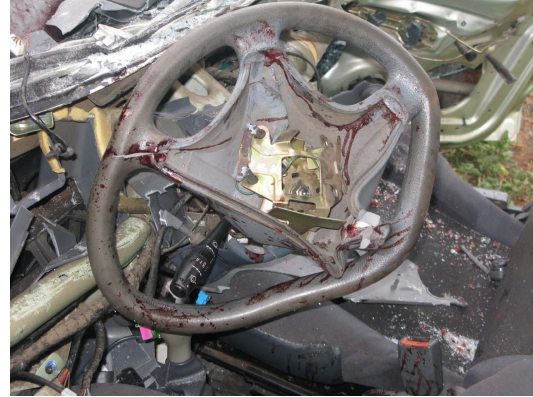
Figure 14: Example of Steering Wheel Contact

An example of occupant contact to the steering wheel is shown in Figure 14. In this frontal crash, the unrestrained driver's chest and head came into contact with the steering wheel rim

and hub. A collapsible steering column and frontal airbags along with belt use would have been highly effective in preventing or reducing the severity of injury.

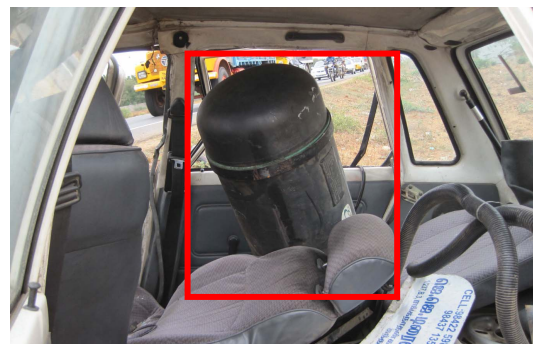
Figure 15: Example of an Aftermarket LPG Tank Contacting Front Seat

Aftermarket parts are observed to be much more common and sometimes unique to the Indian market than they typically are in western countries. Add-on parts such as brush guards and Liquefied Petroleum Gas (LPG) tanks were seen on several case vehicles. These parts can have unintended consequences during a crash, causing damage to the interior of a vehicle, as illustrated in Figure 15. In this crash, the aftermarket LPG tank was not secured properly and moved forward from the trunk during a frontal impact, striking the back of the driver seat and potentially causing occupant injury.

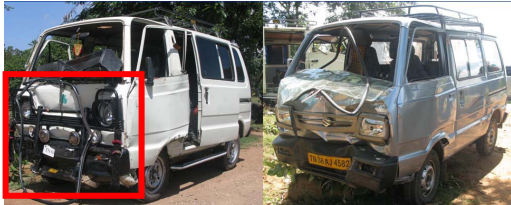
Figure 16: Example of Vehicles Involved in a Head-On Crash, One with an Aftermarket Brush Guard (Left) and One Without (Right)

Aftermarket parts can also increase the severity of crush and intrusion to the exterior of a vehicle. In this crash, the crush and intrusion to the front of the vehicle followed the outline of the brush guard. It was determined that the brush guard

pushed into the vehicle’s own passenger compartment, causing more damage to the vehicle than if it had not been there. As shown in Figure 16, this was determined because the vehicle struck another similar vehicle without a brush guard, and the other vehicle had much less severe intrusion and damage as a result of the impact.

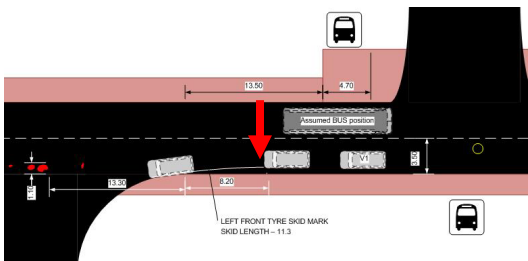
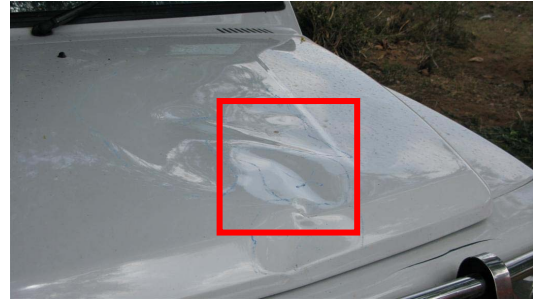
Figure 17A and 17B: Example of a Pedestrian Crash with Head Contact to the Hood

In addition to vehicle occupants, several cases involving pedestrians were investigated. Figure 17A illustrates a case where a pedestrian was attempting to cross a roadway immediately after exiting a bus. There was no pedestrian infrastructure at this bus stop and the pedestrian’s vision was obstructed by the back of the bus while crossing the street. Upon examination, it was found that the head of the pedestrian had contacted the hood of the vehicle during the collision, as evidenced by the dent in the hood shown in Figure 17B. The high number of pedestrian head contacts to the hood observed during the study highlights this as an important component for further review and analysis of pedestrian safety.

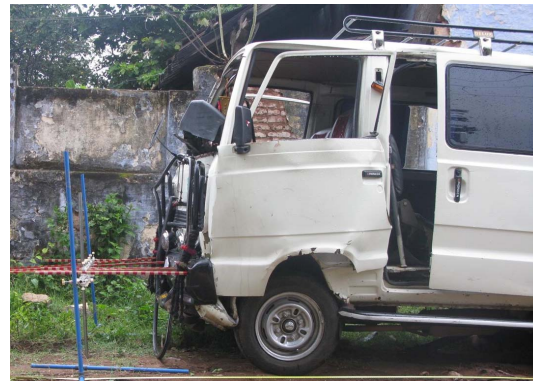
Figure 18: Example of the Lack of Crumple Zone

Another issue identified was the lack of crumple zones on the front of some vehicles, as illustrated in Figure 18. If this vehicle had been equipped with a larger frontal structure, there would have been more room for the vehicle to absorb the crush from the impact before intrusion into the passenger compartment began.
